HORSE POND DAM

REPAIR PROJECT

HORSE POND DAM
WAS ORIGINALLY BUILT IN 1894

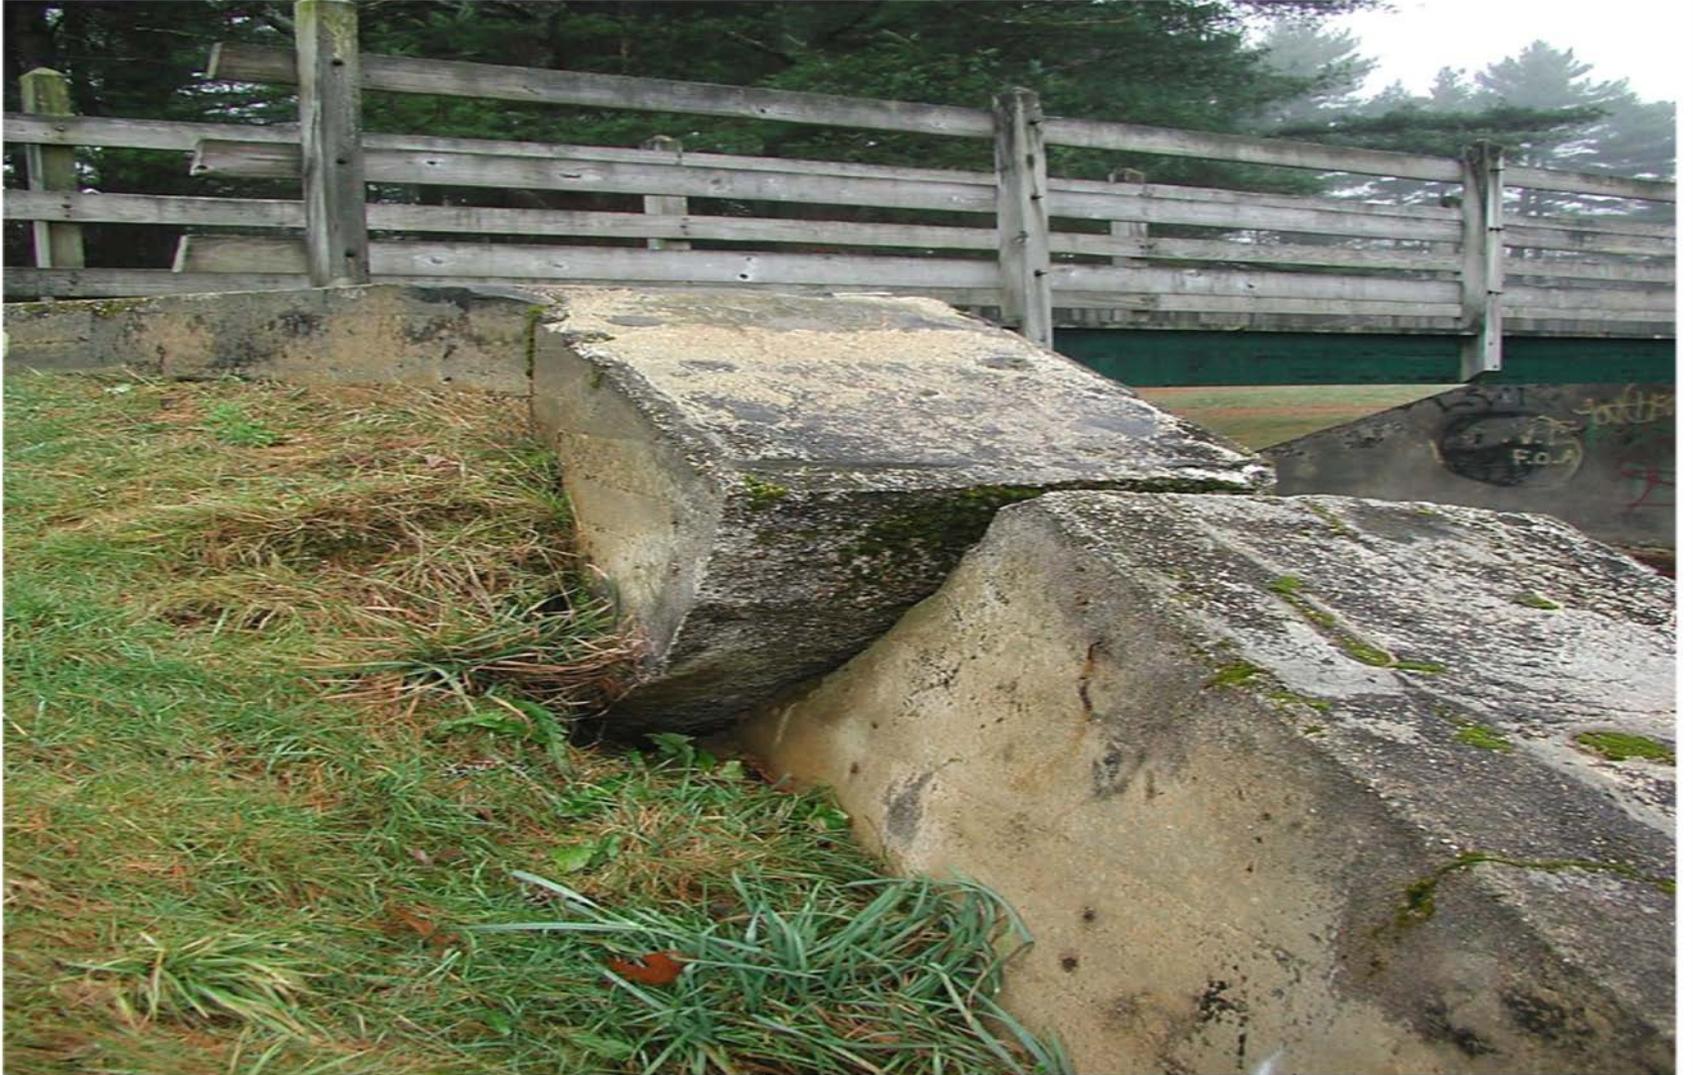
- Over the years, the dam spillway had been repaired but by 2000 the walls were cracked and leaning.

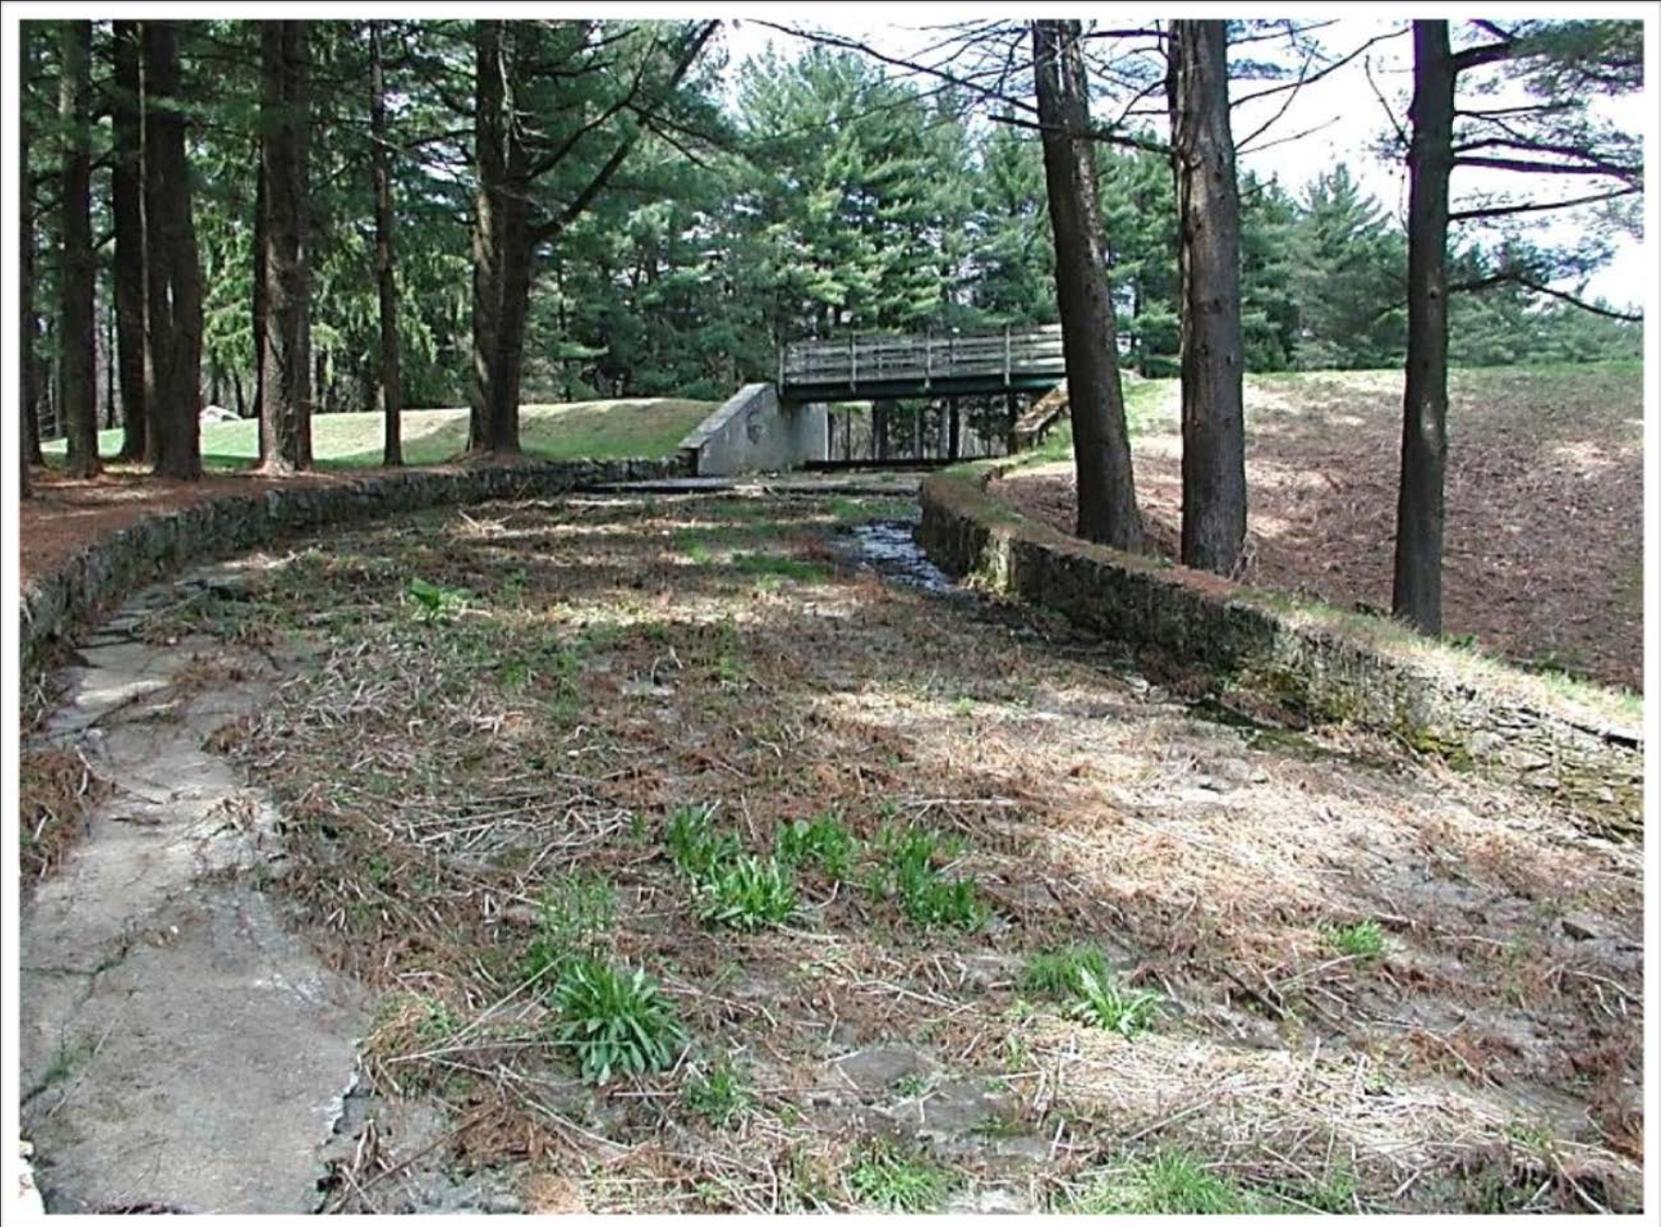
- The spillway masonry was deteriorating. This allowed vegetation to grow which caused more deterioration.

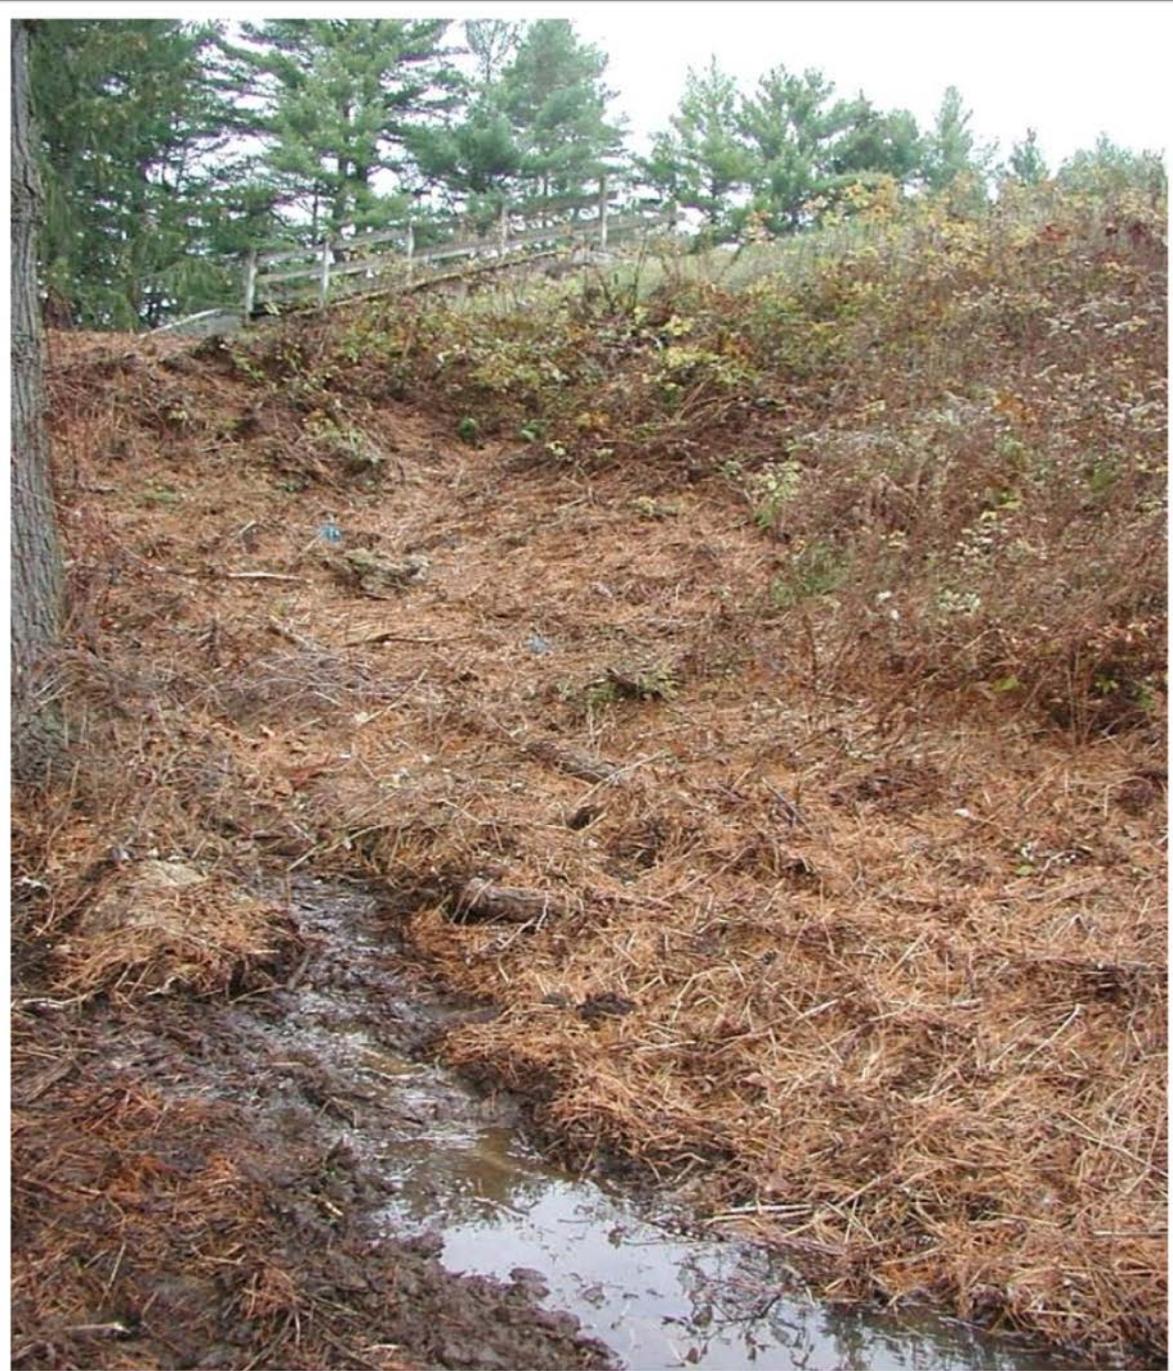
- Two large pine trees were growing into the dam. Water was seeping through the dam by these trees.
- All earthen dams seep to some extent but uncontrolled seepage is not good in that it can carry out particles of soil from the dam, thereby weakening the dam.

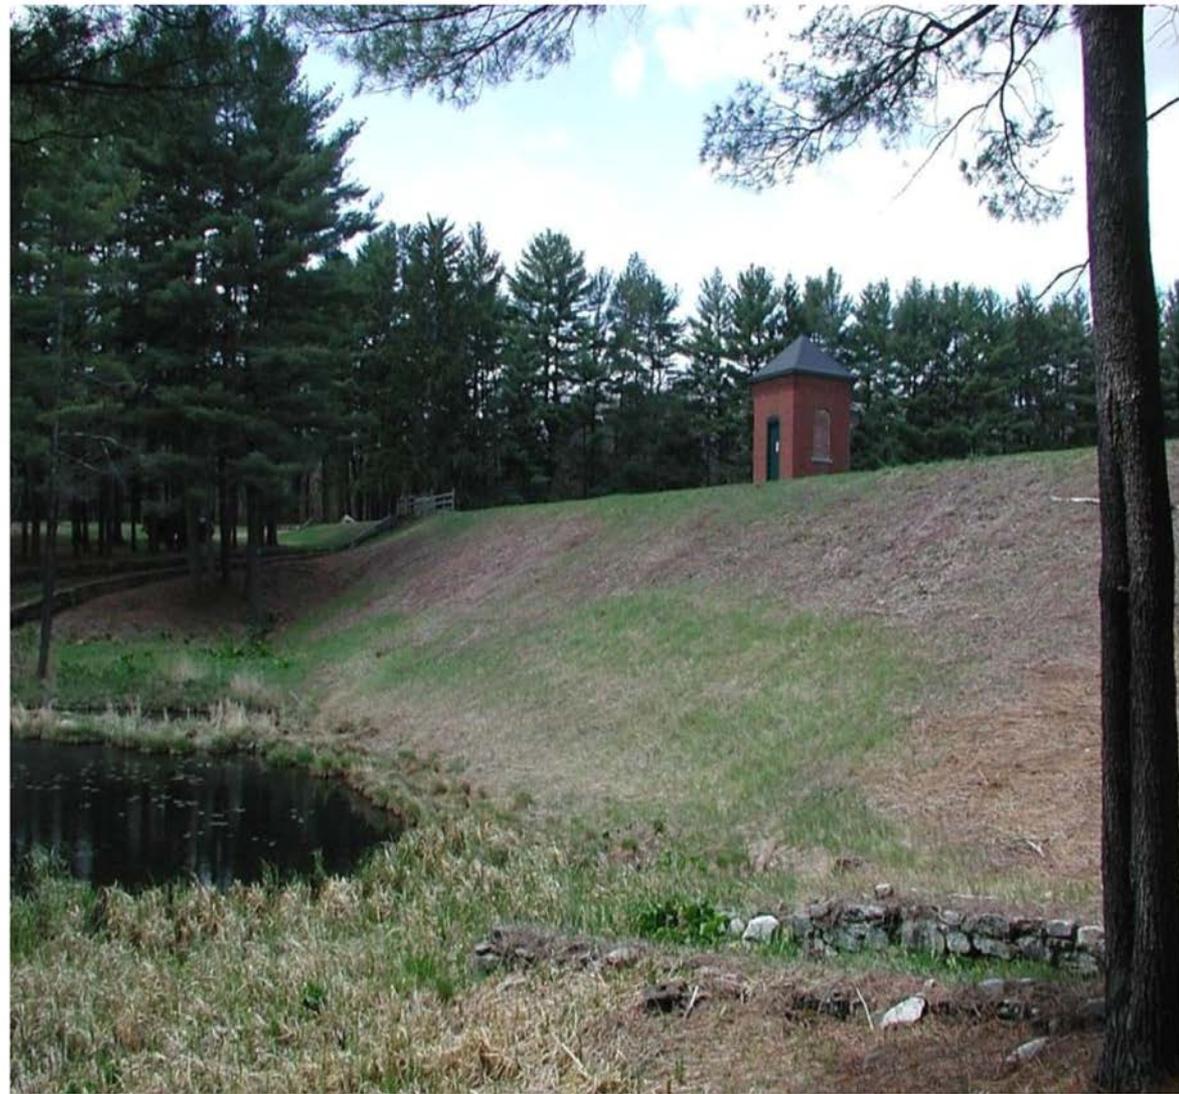
- The 36” low level outlet gate valve at the bottom of the dam, was inoperable.
- In 2006, GZA Engineering was hired to conduct a Phase 1 inspection of the dam. The inspection resulted in a “Poor” rating which brought an Administrative Consent Order from the Massachusetts Office of Dam Safety to repair the problems.

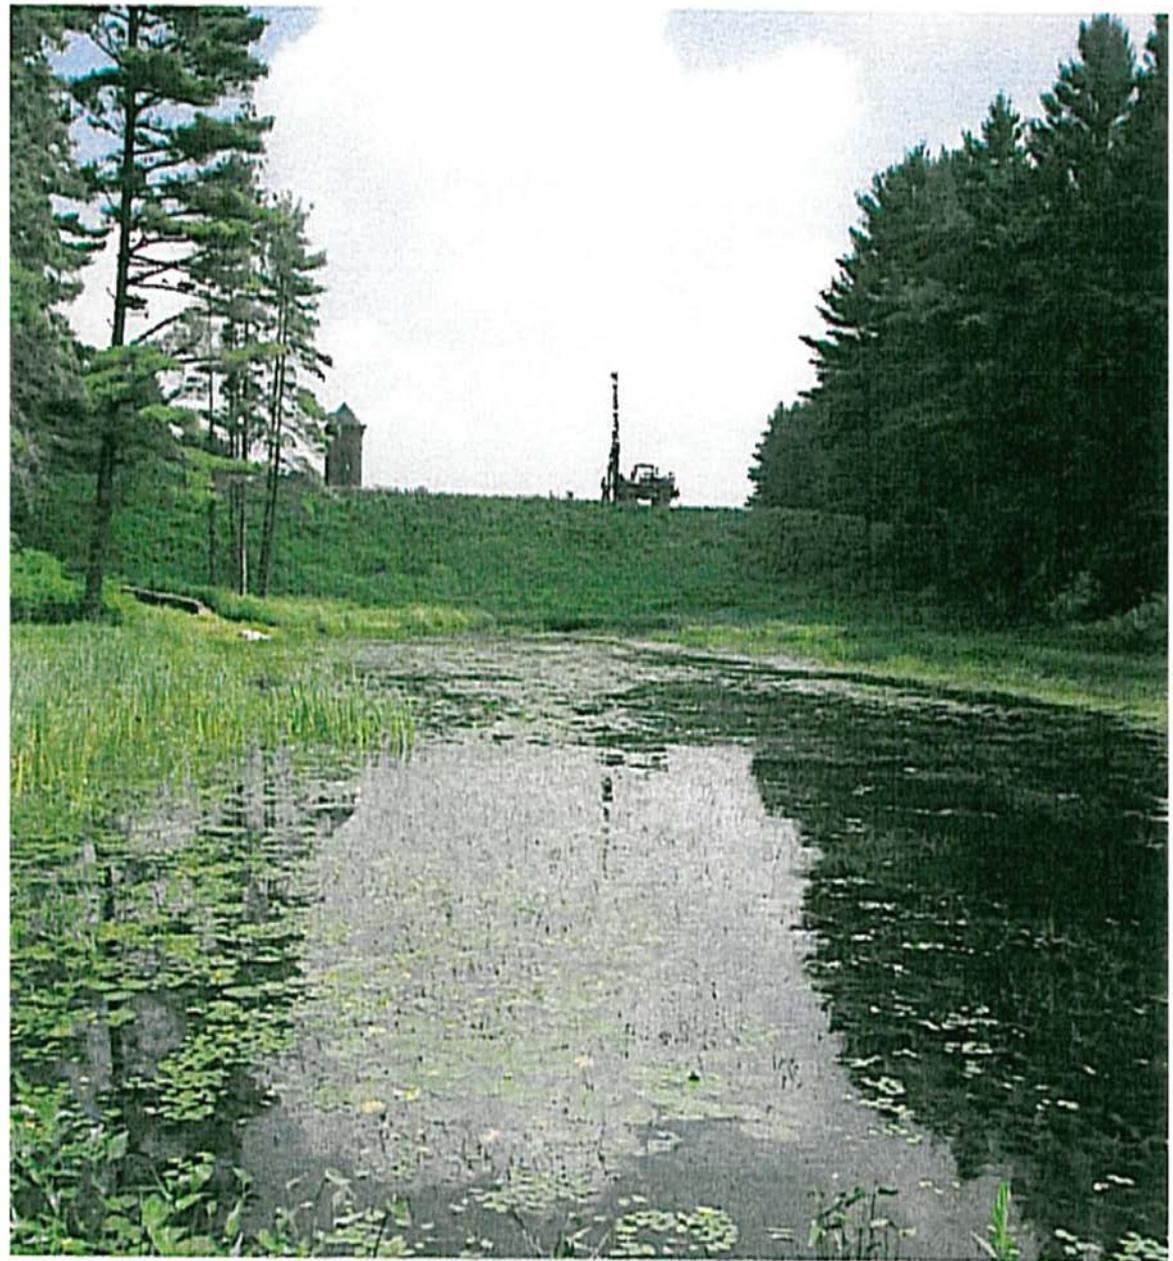
- Lenard Engineering was hired to conduct a Phase 2 inspection.
- This inspection was much more thorough and included borings into the dam itself.

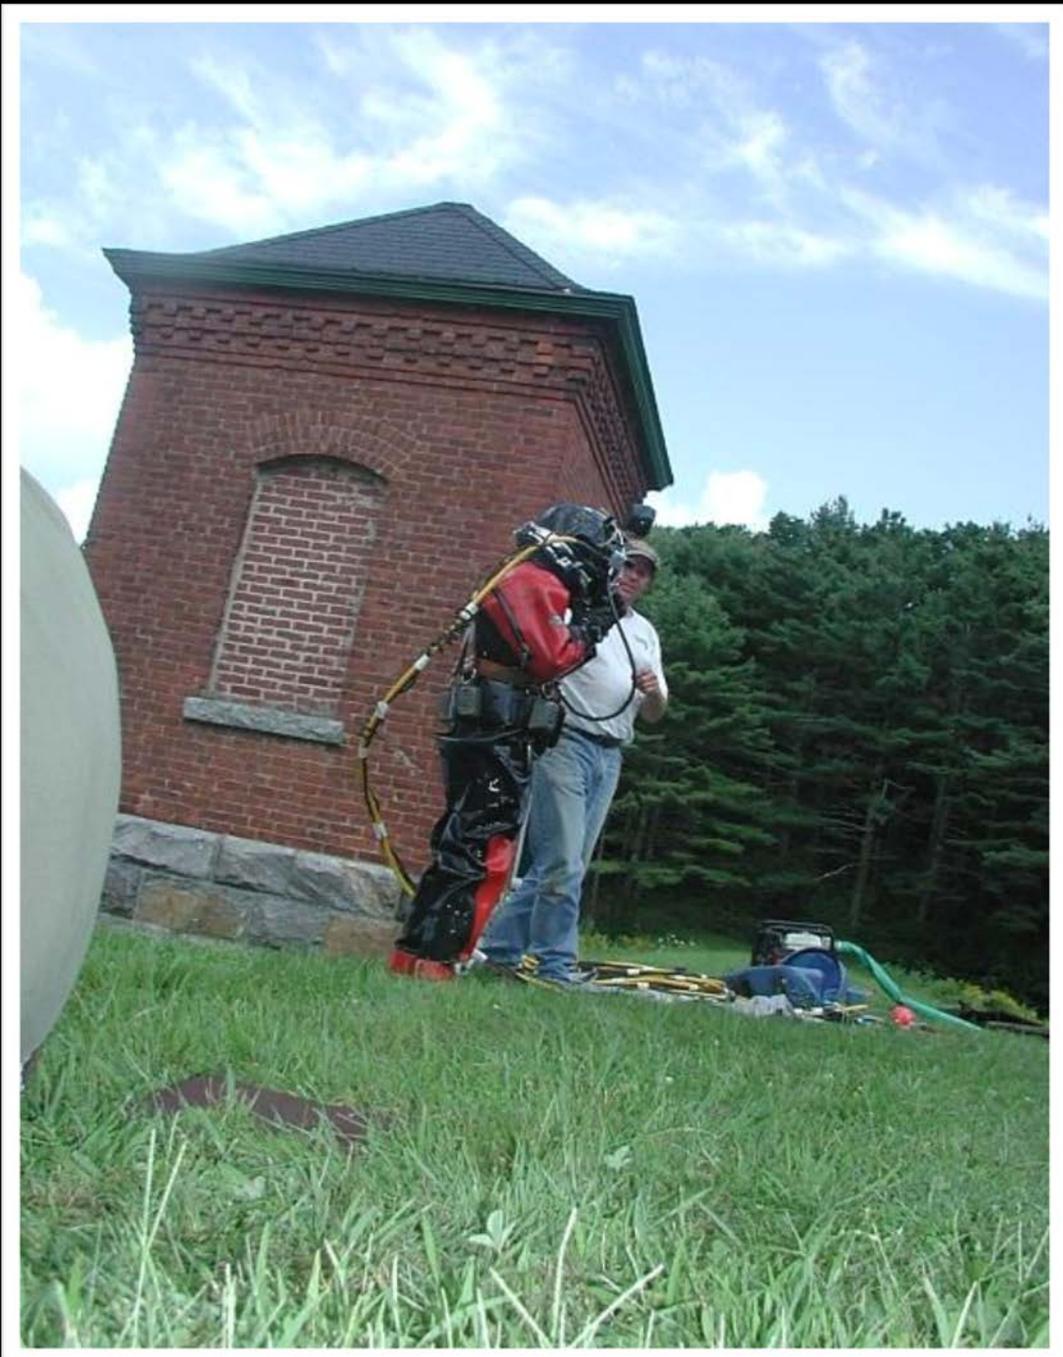
- Divers inspected the base of the gatehouse, the low level influent pipe, and the condition of the upstream slope of the dam.
- Lenard Engineering was then hired to design the repairs that were needed.
