HORSE POND DAM

REPAIR PROJECT

HORSE POND DAM
WAS ORIGINALLY BUILT IN 1894

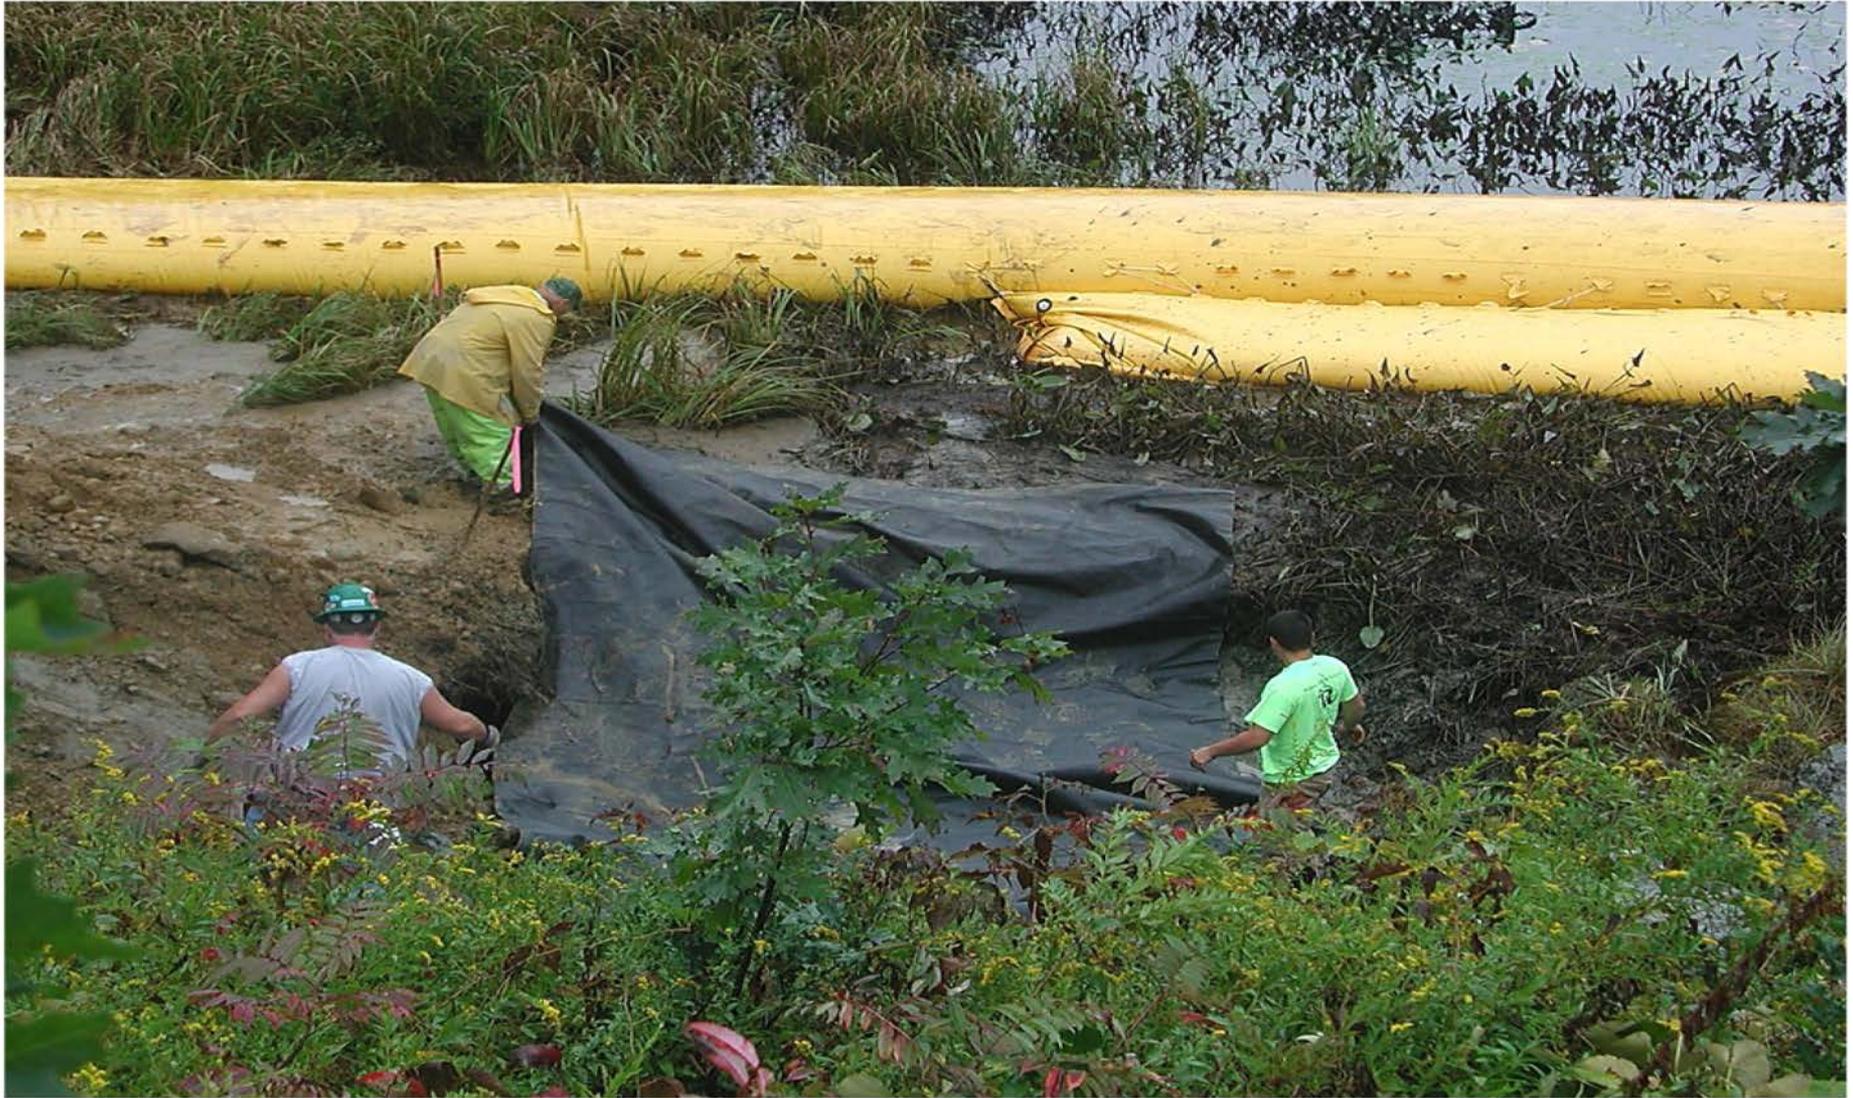
- The blast rock was covered by filter fabric, which was then covered by gravel.

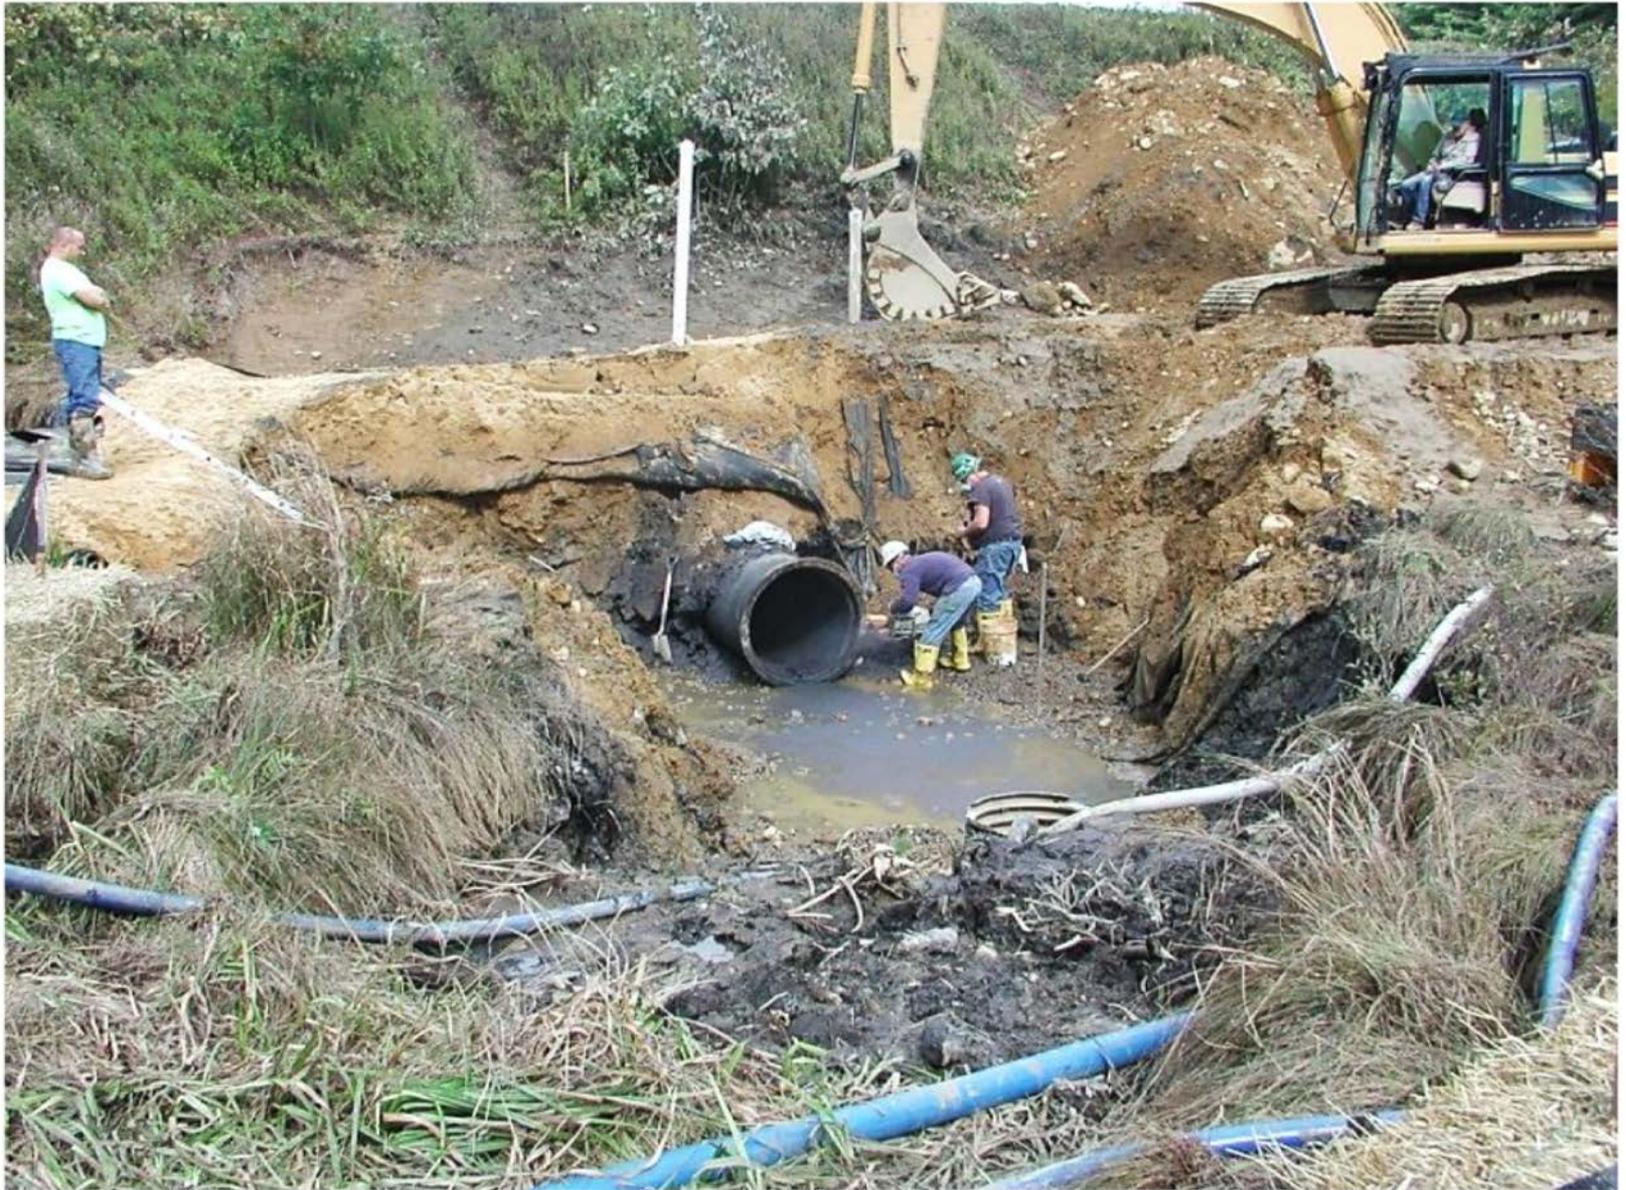
- Since the back of the dam was being extended, the 36" cast iron low level outlet pipe had to also be extended.

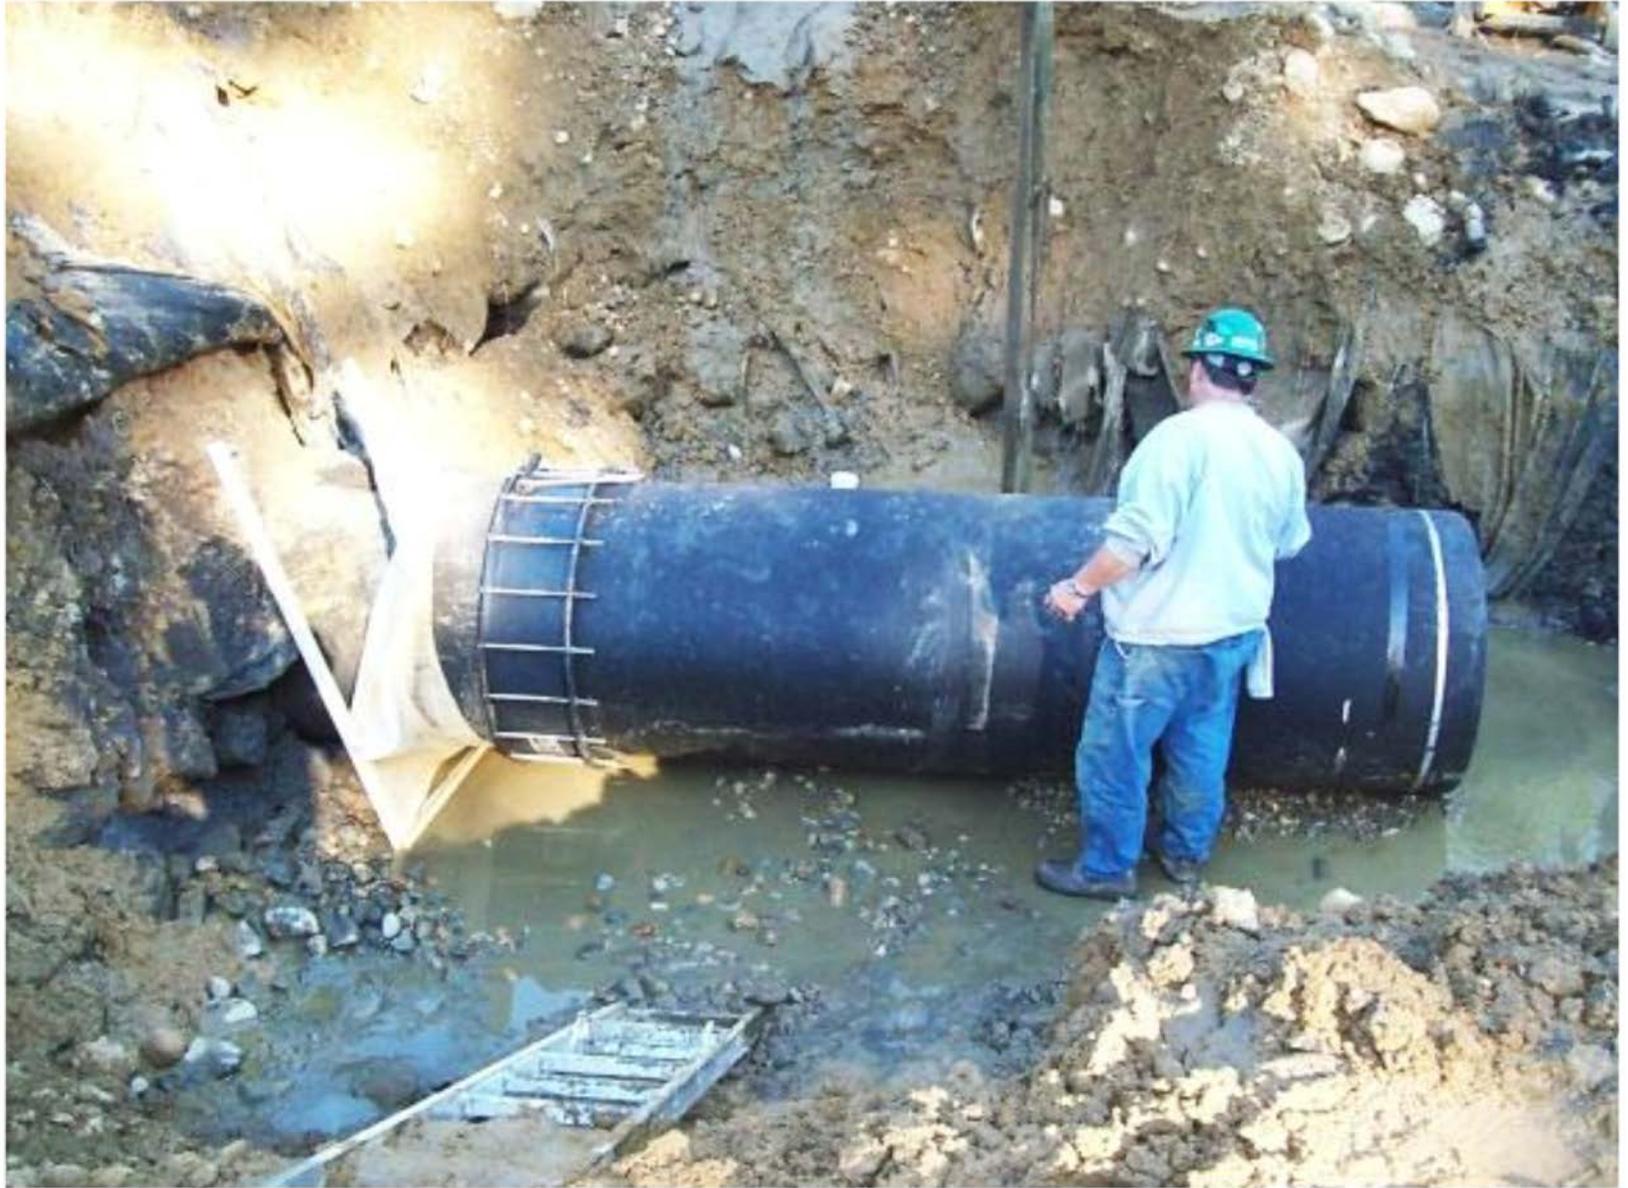
- The ductile iron pipe was then connected to the original cast iron pipe.

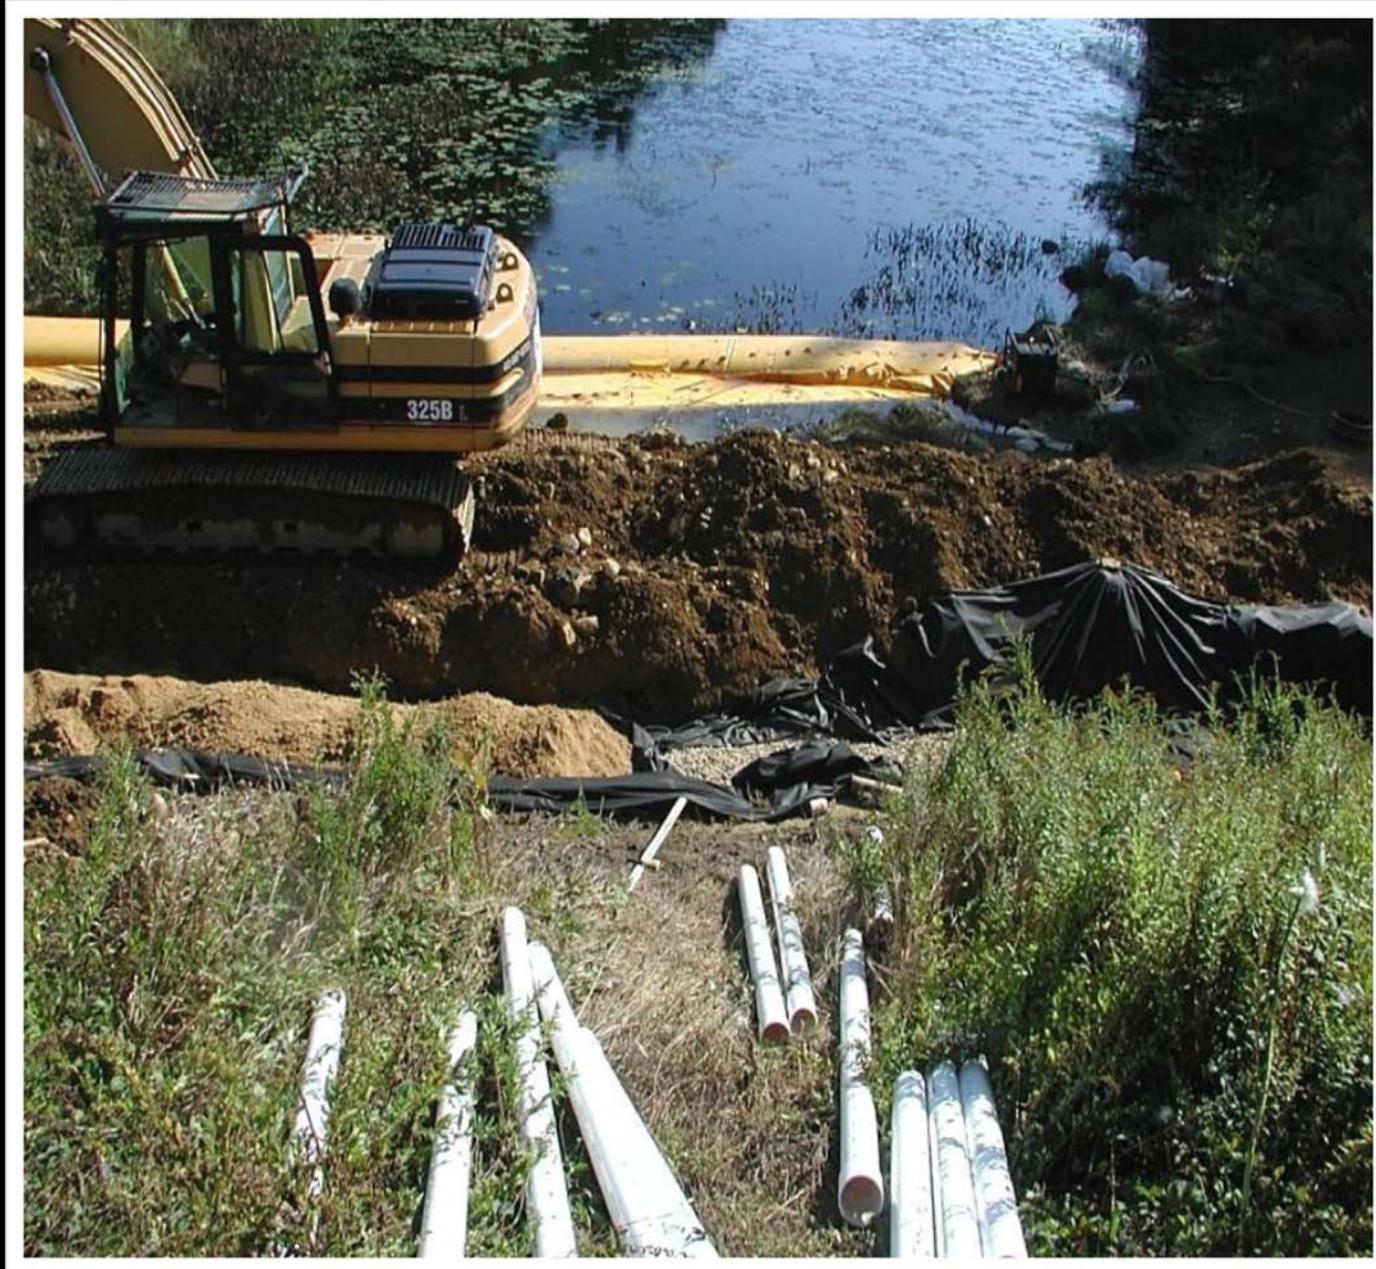
- A drainage system was installed at the base, or toe, of the dam at the same time.
- The drainage system consisted of perforated 4" PVC pipe laid in stone, covered with filter fabric and then backfilled with sand.

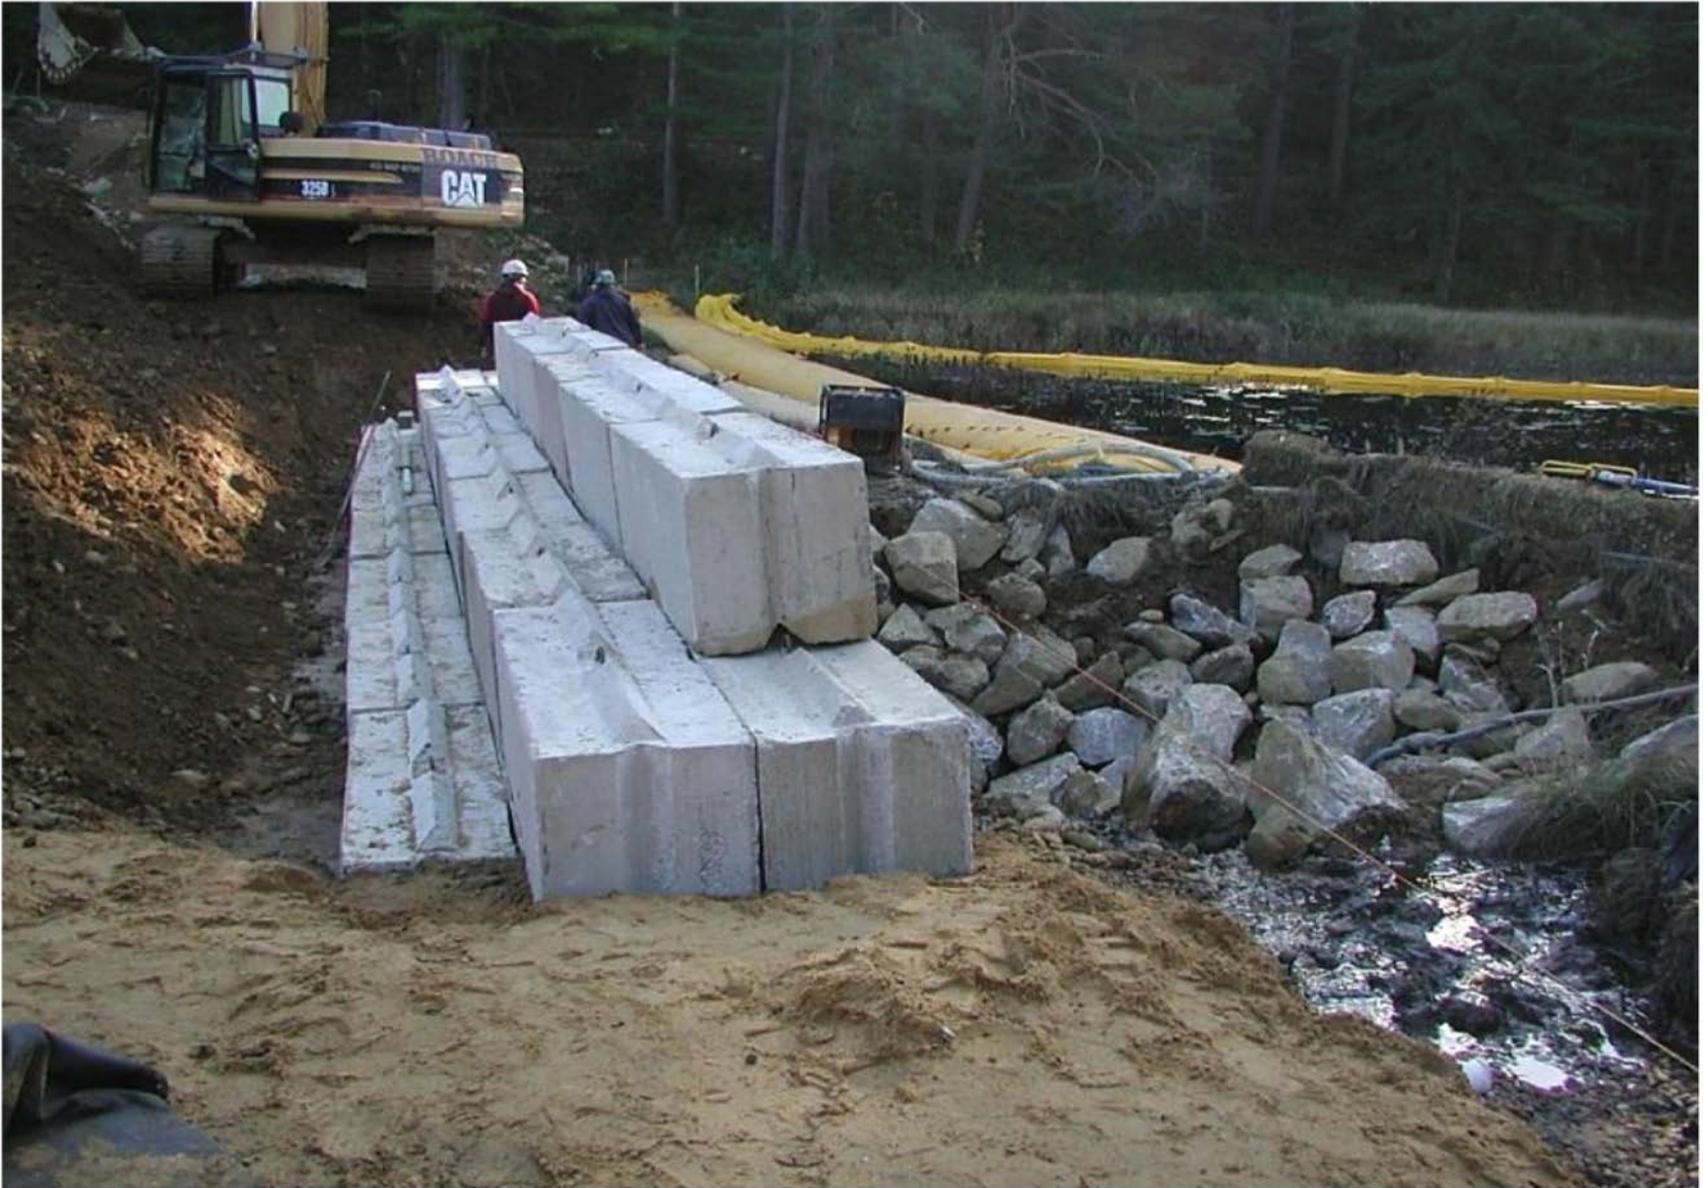
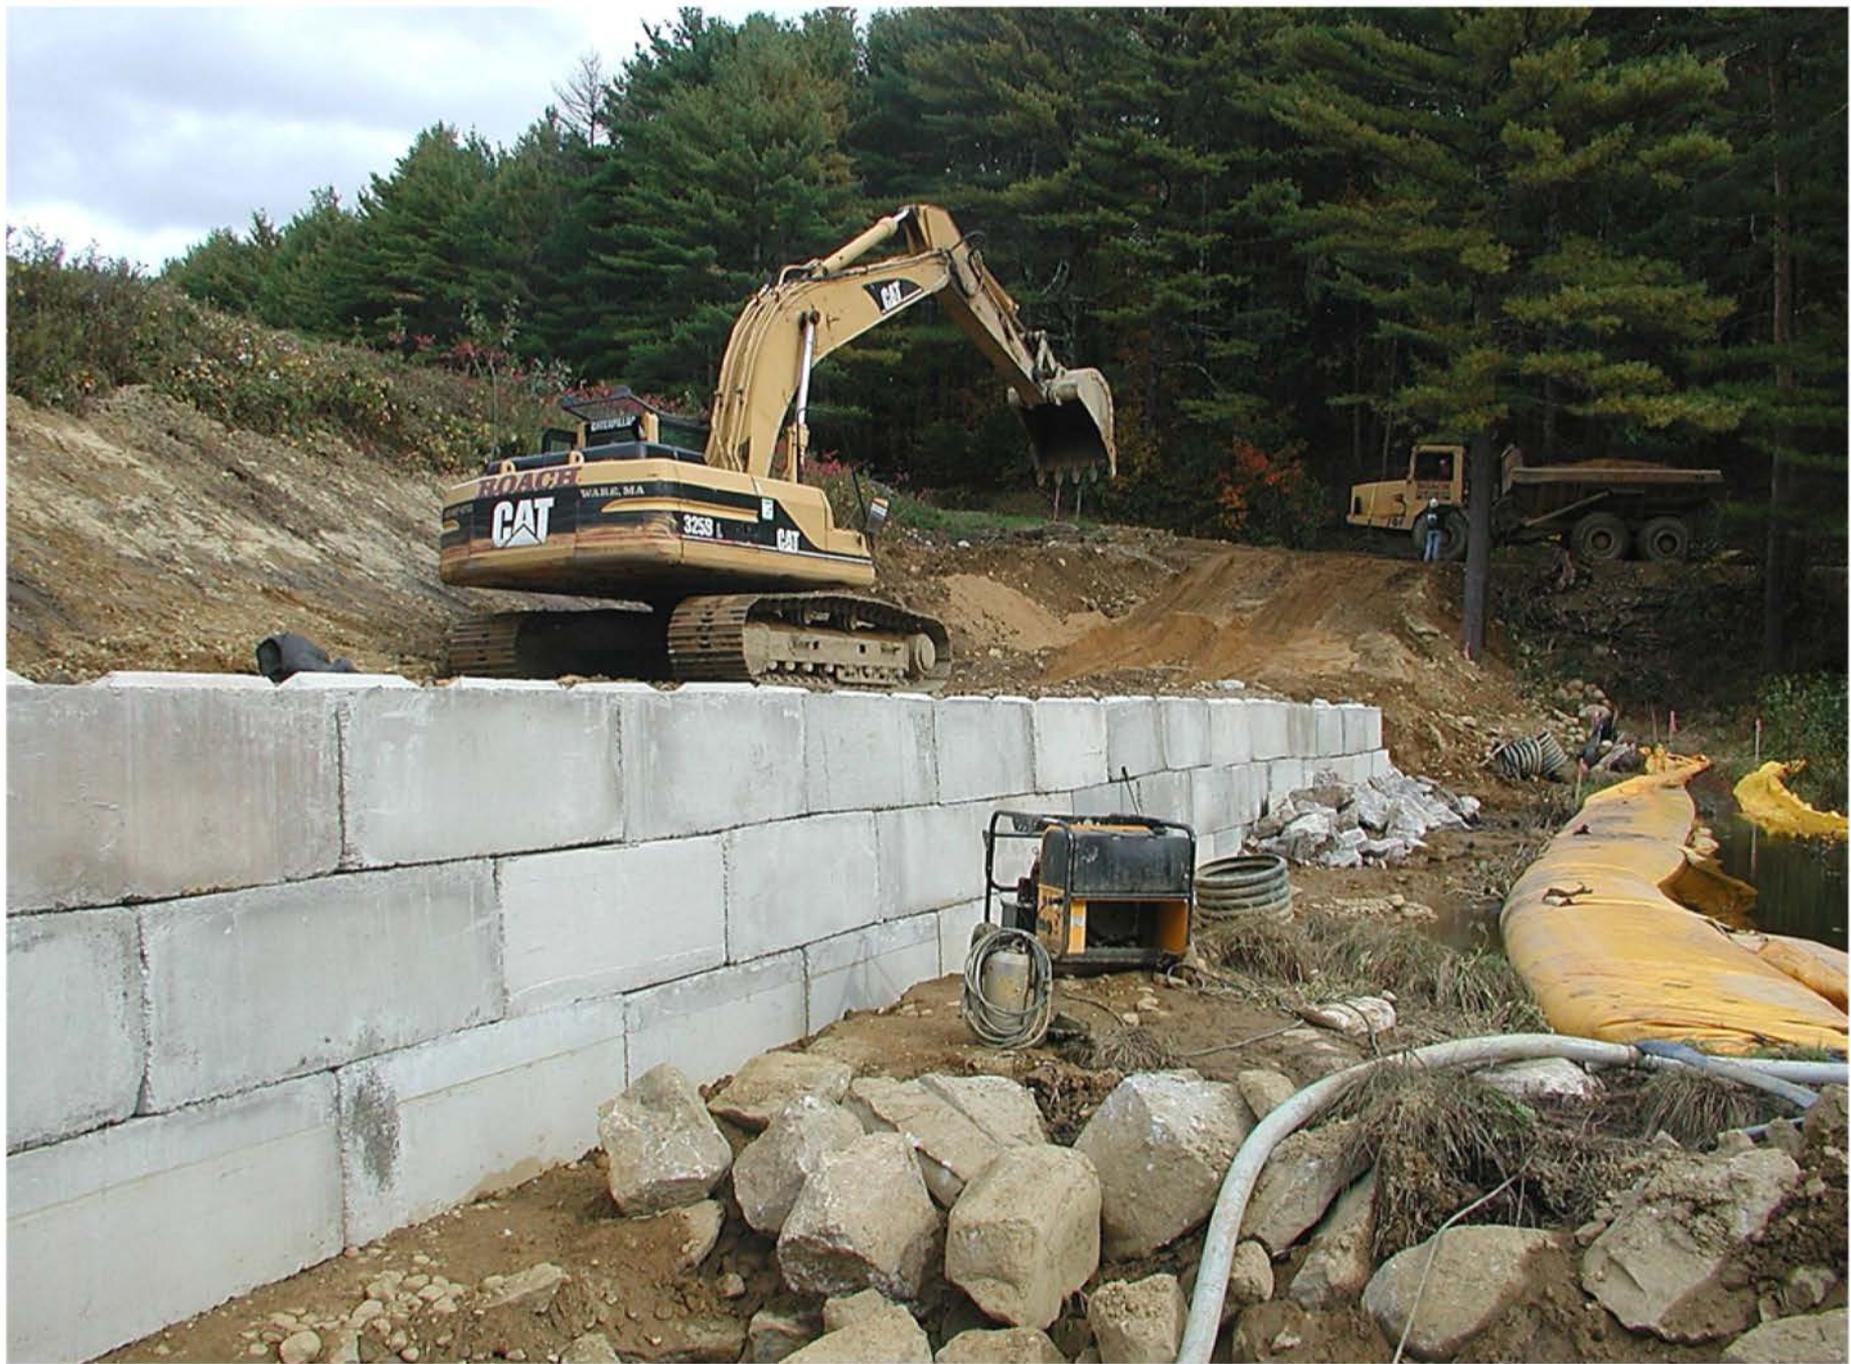
- A cement block wall was constructed as the final part of the buttress.

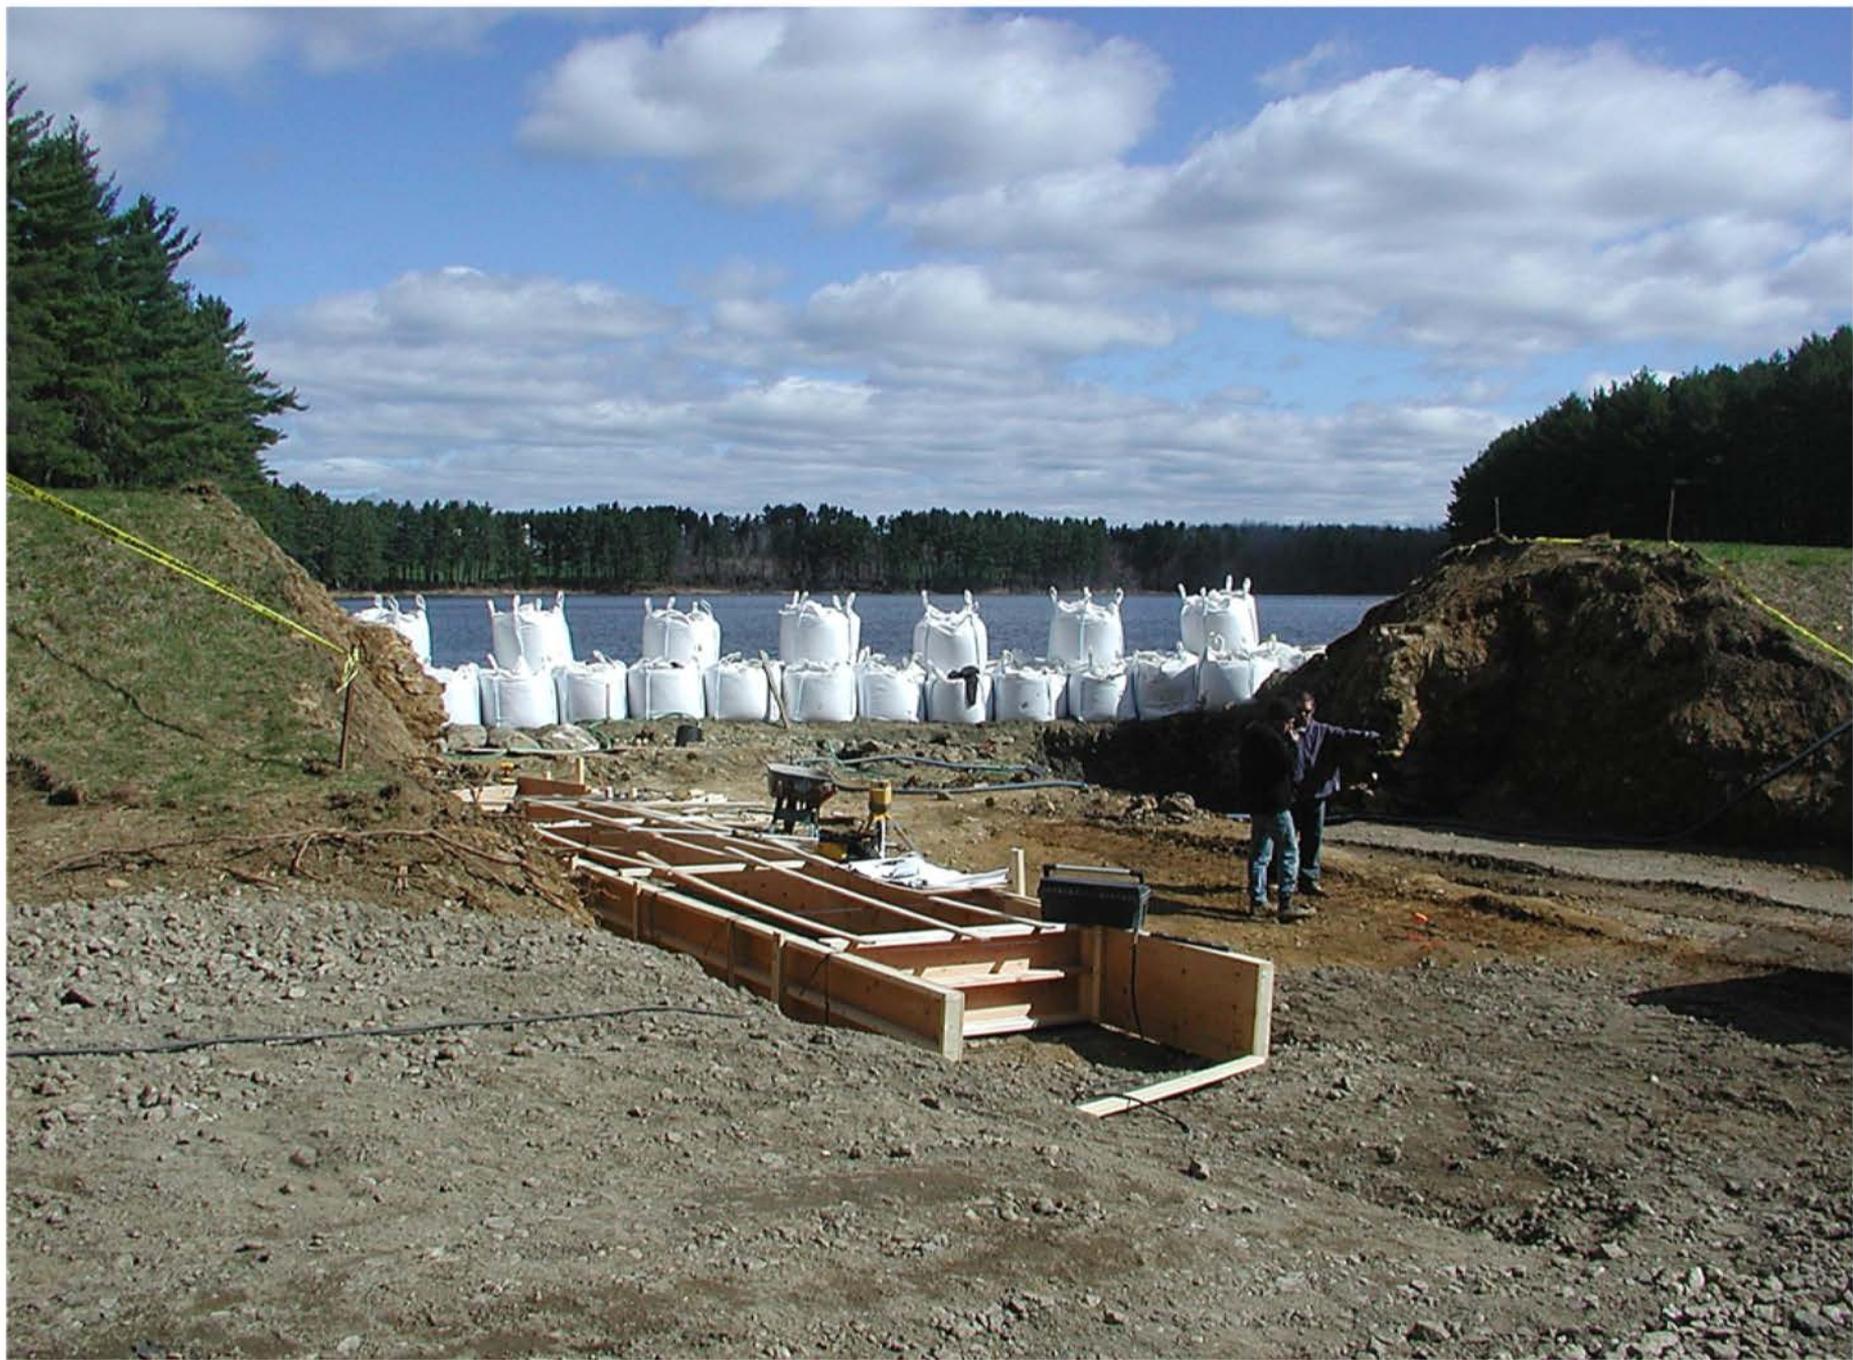
- Rebar was added to the forms to add strength. The cement was poured into the forms and worked by the crew.

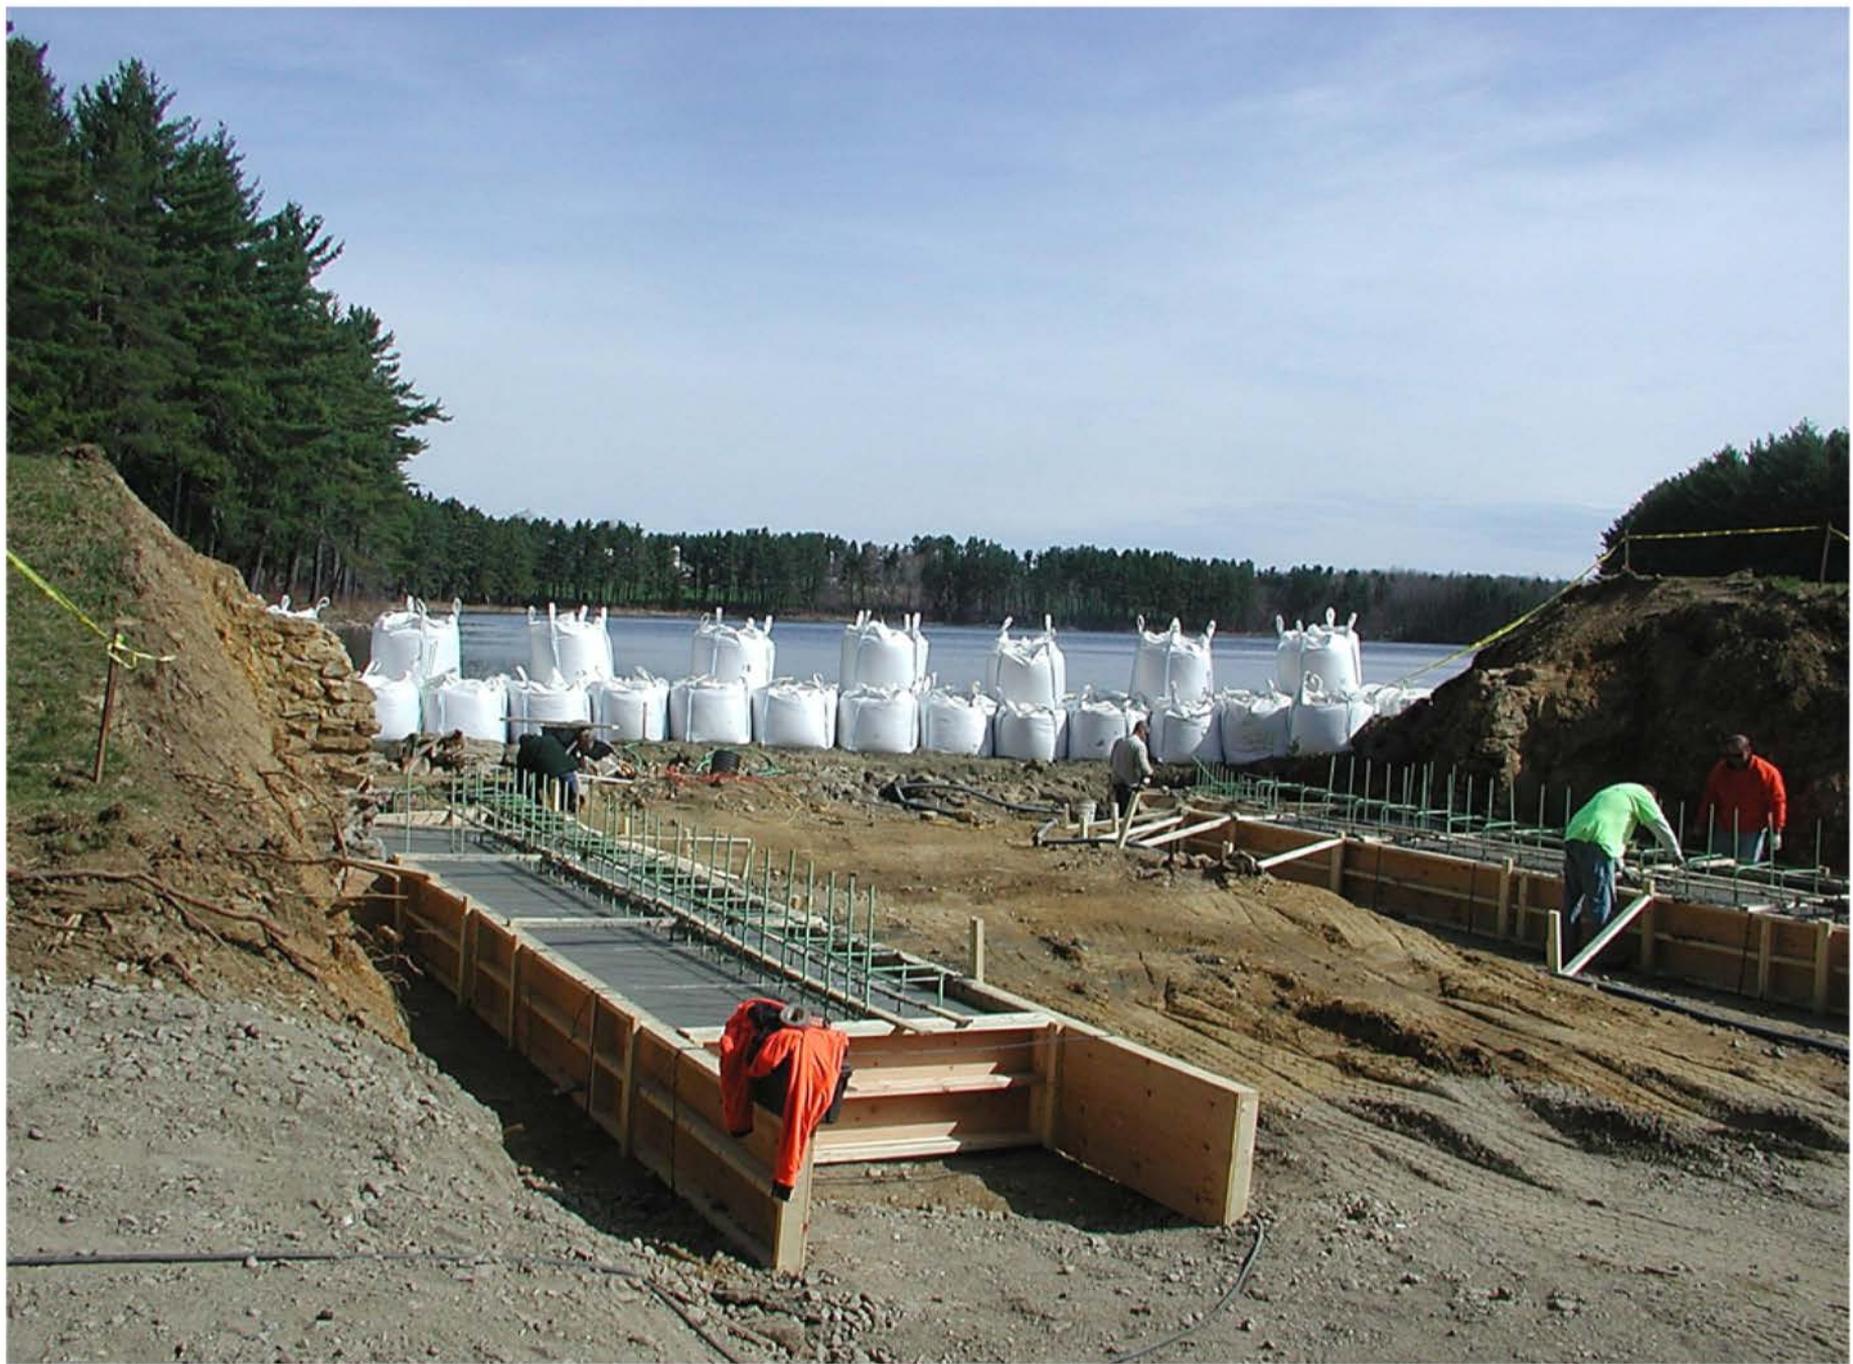
- The cement was tested by an independent company to insure the quality.

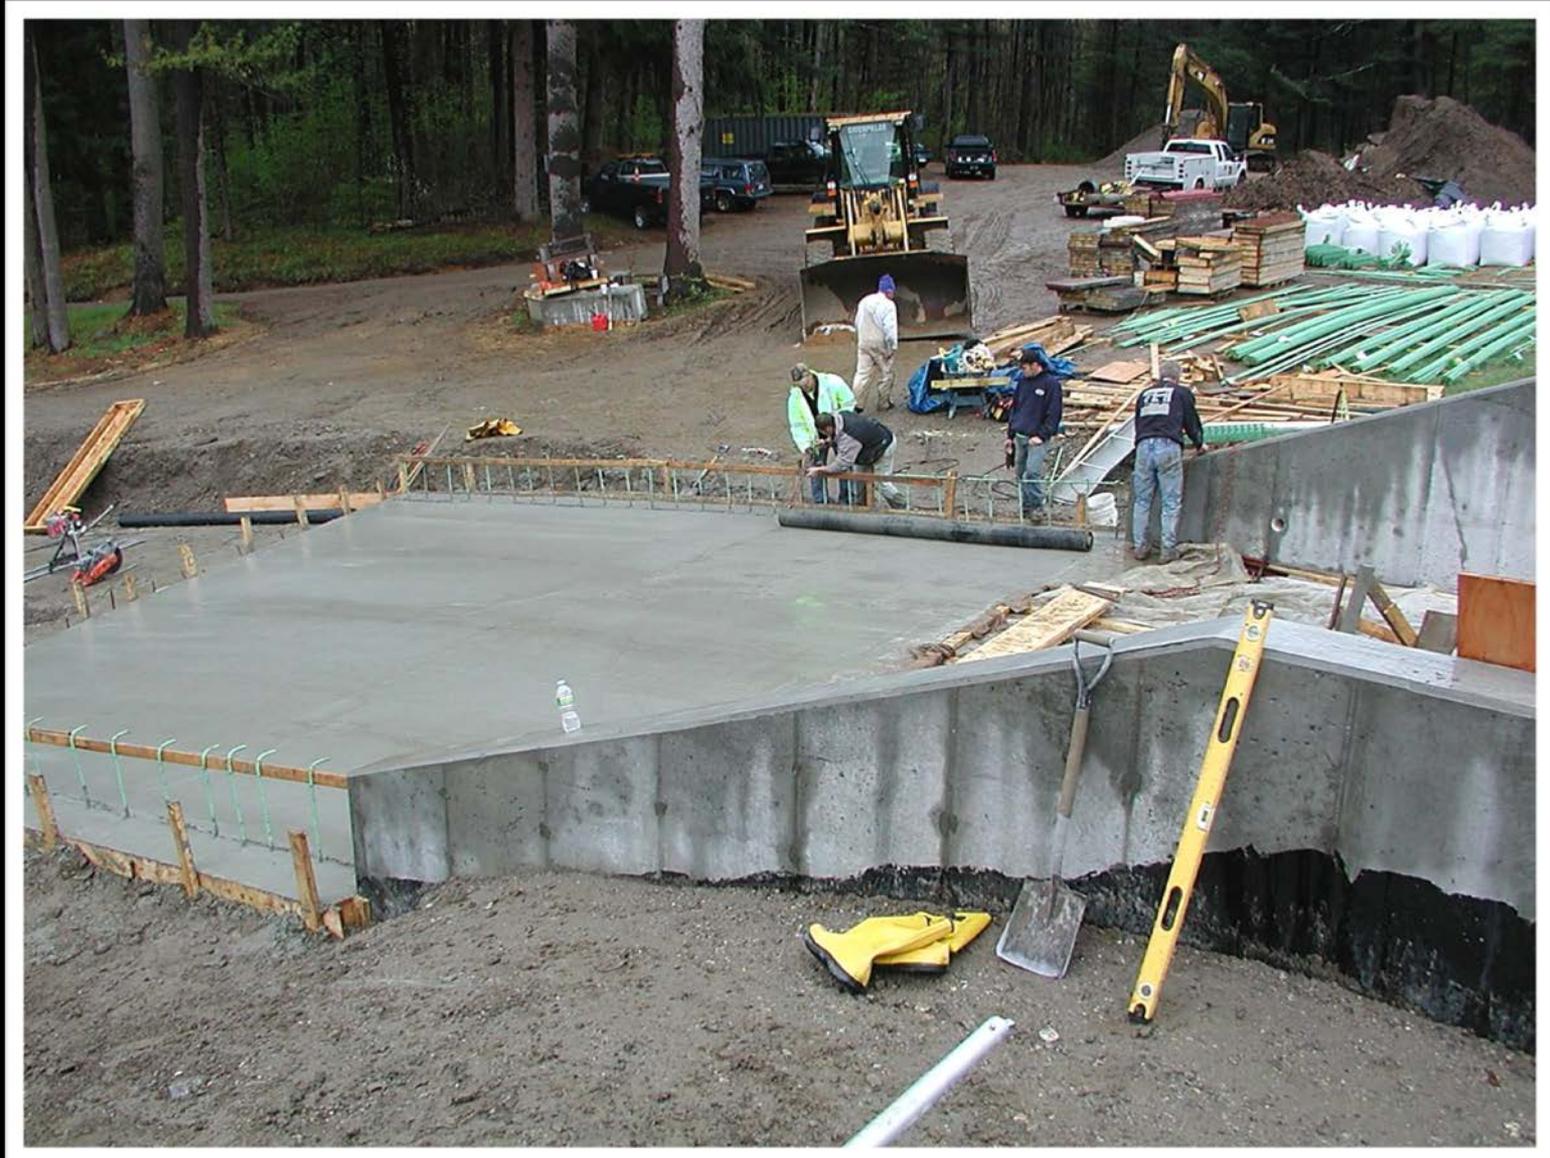
- Sheets of burlap were placed on top of the cement after pouring to hold in moisture so it would dry slower and prevent cracking.

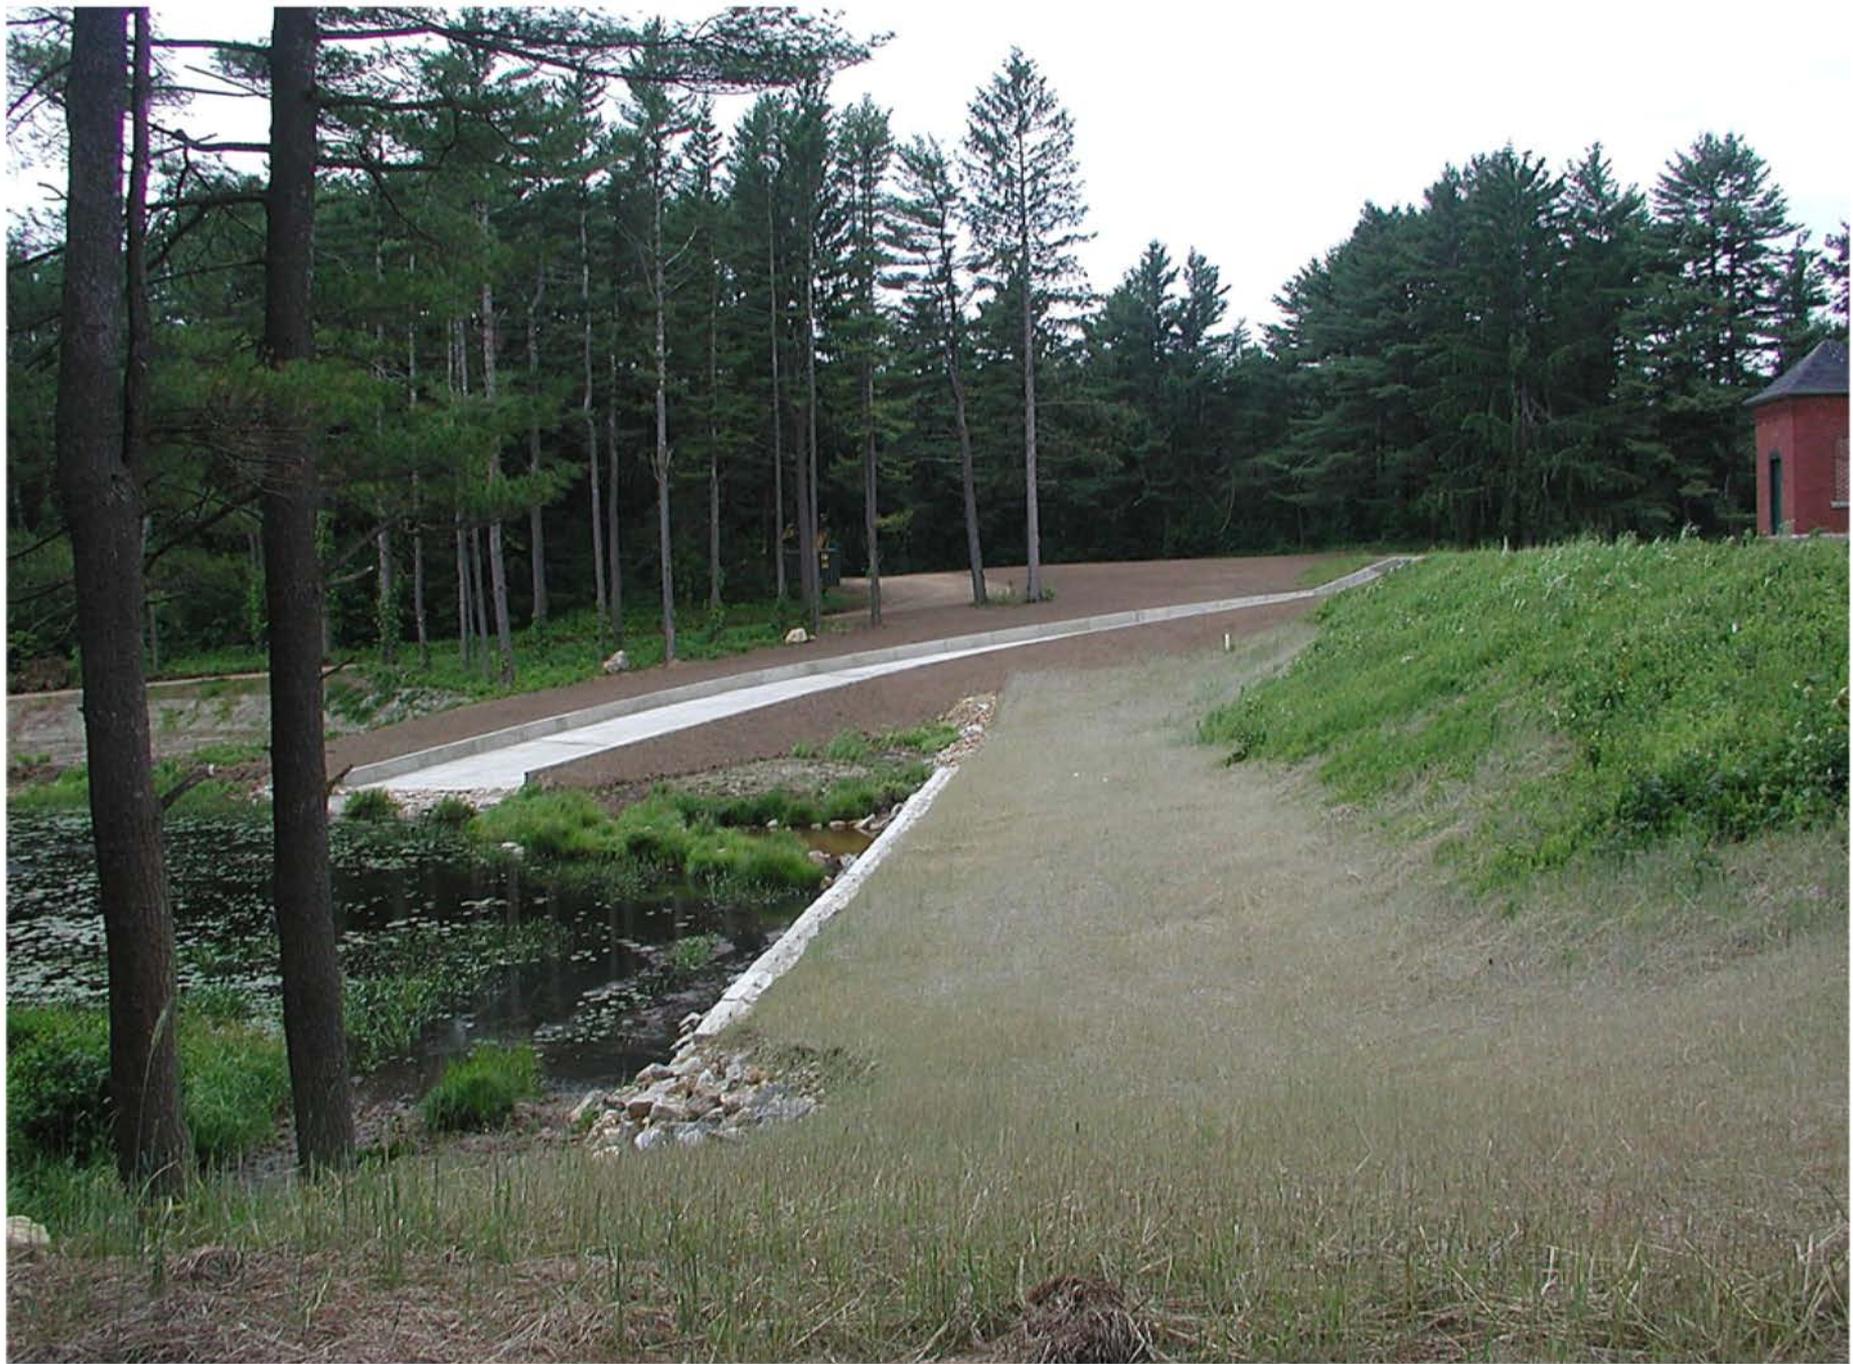
- Construction of the new walkway.
