HORSE POND DAM

REPAIR PROJECT

HORSE POND DAM
WAS ORIGINALLY BUILT IN 1894

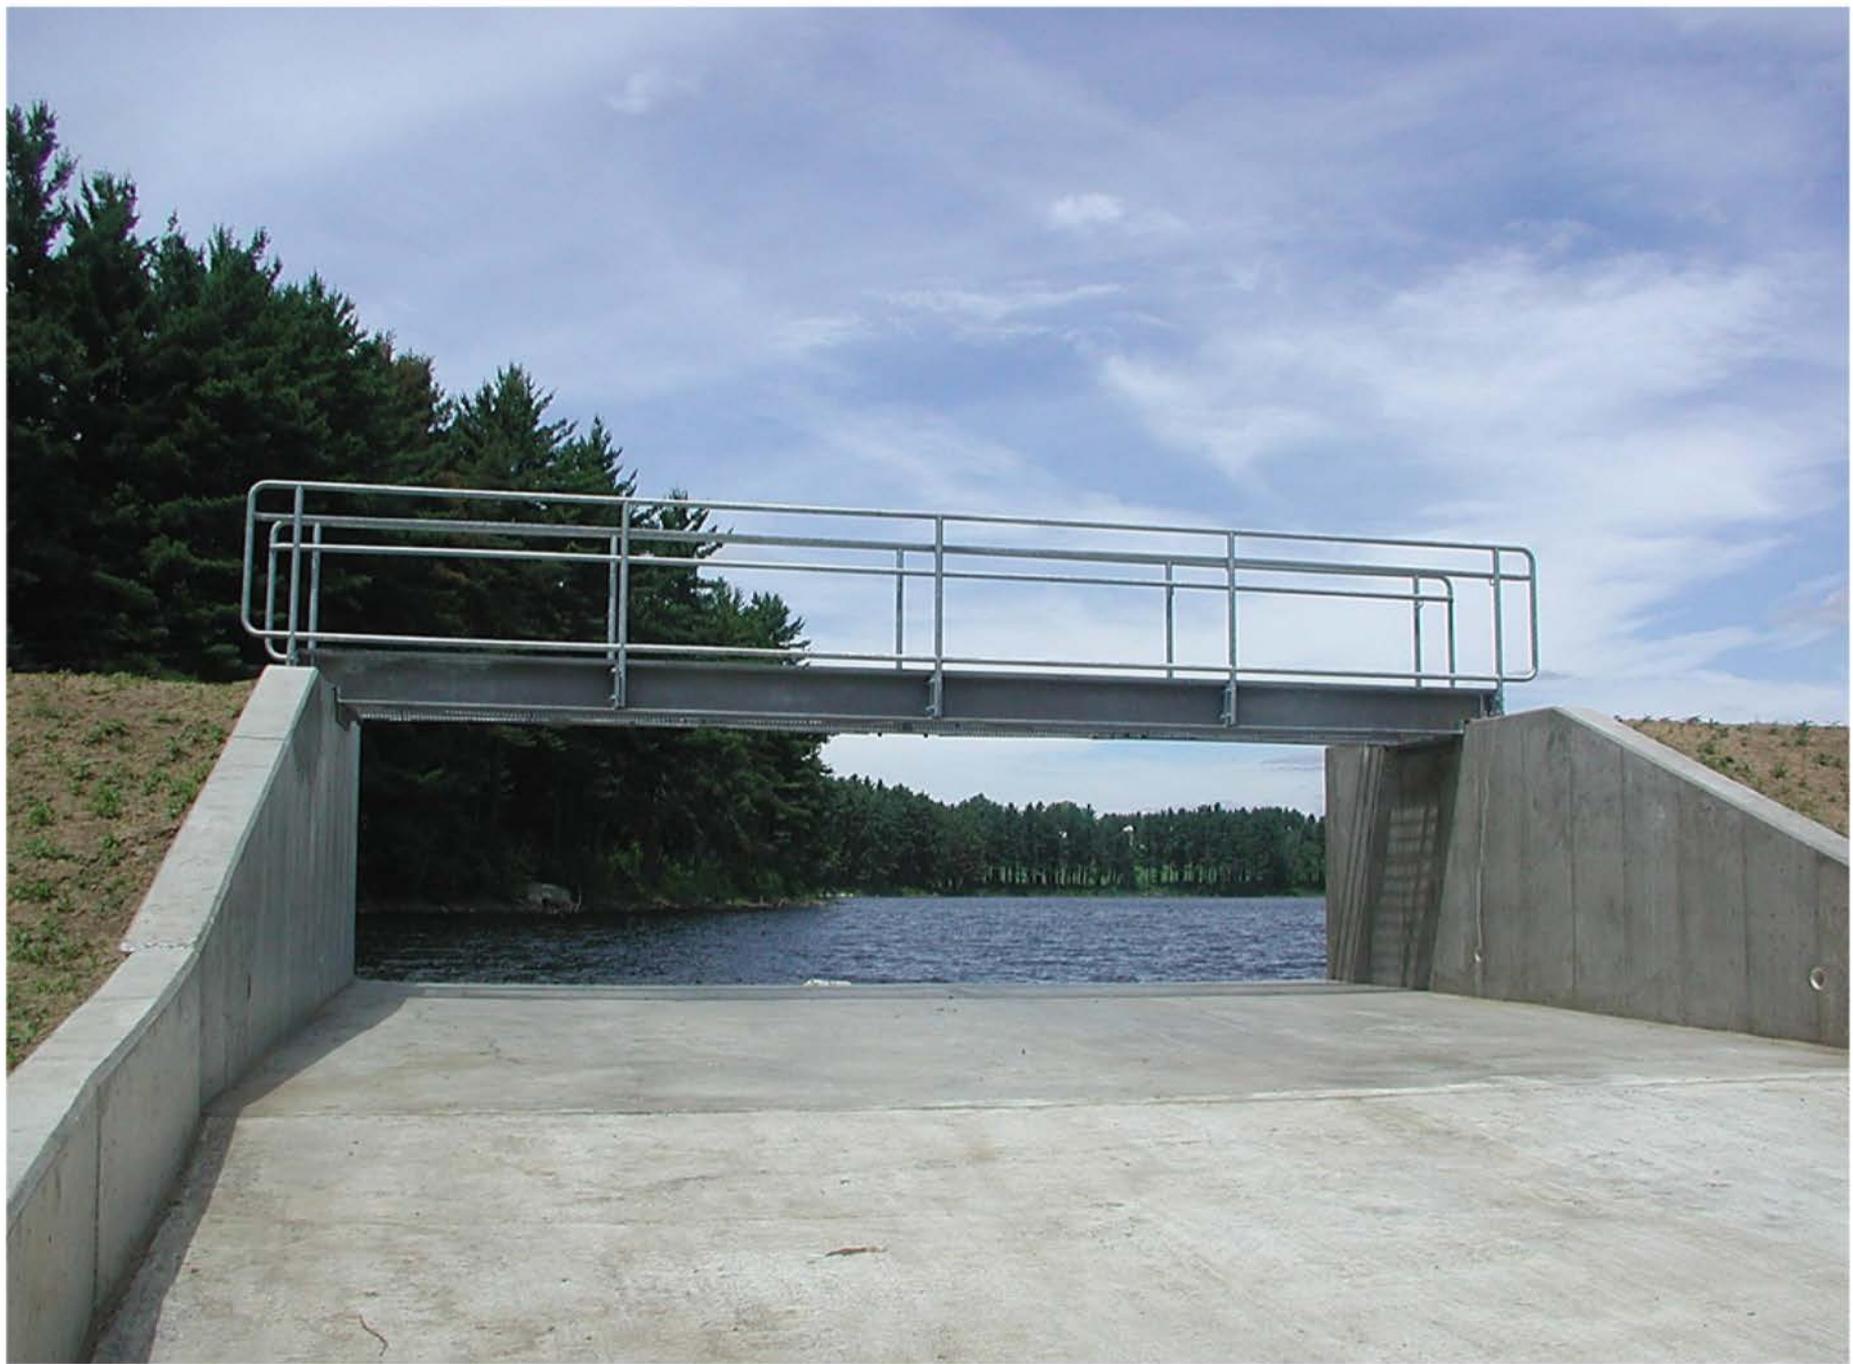
- The weir board was connected to the walkway and spillway. This set of 3 aluminum “boards” allows the reservoir to be raised an extra foot in the spring. This adds twenty million gallons to the usable storage in the reservoir.

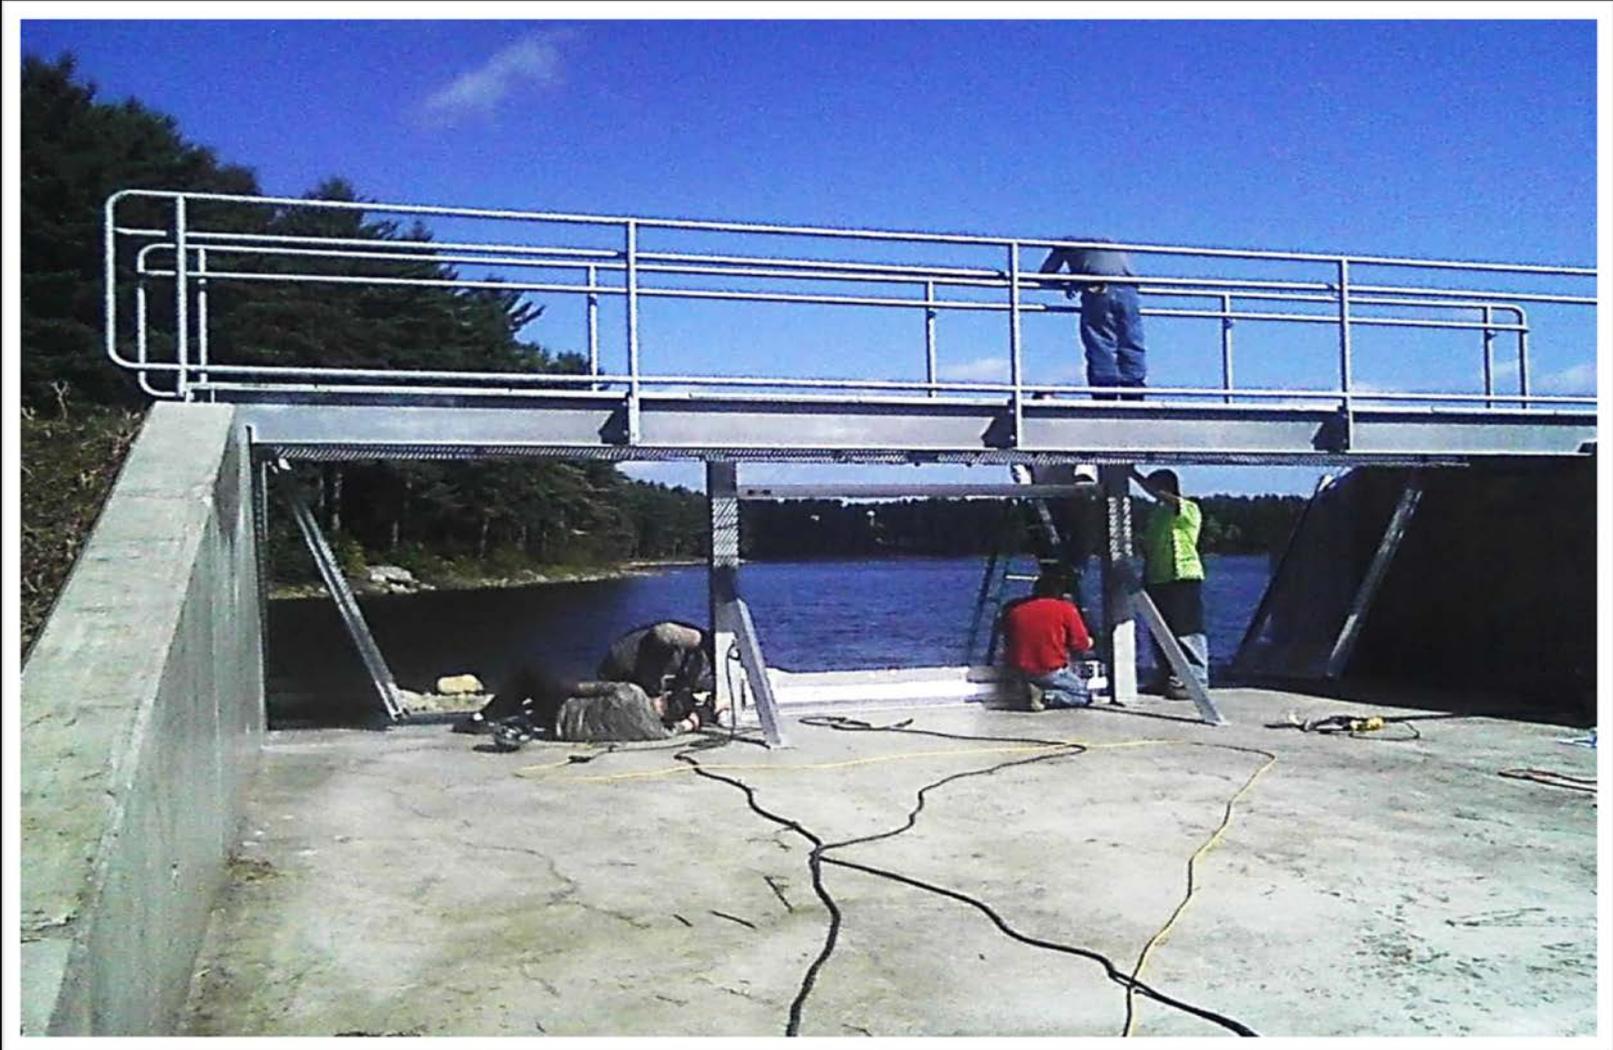
- The center board is raised or lowered using a crank from the walkway.
- We lower the board in the spring to have the extra water during the summer months and then raise it in the fall when the extra water isn't needed.
